Reducing the Risks of Nonstructural Earthquake Damage – A Practical Guide

FEMA E-74 / December 2012

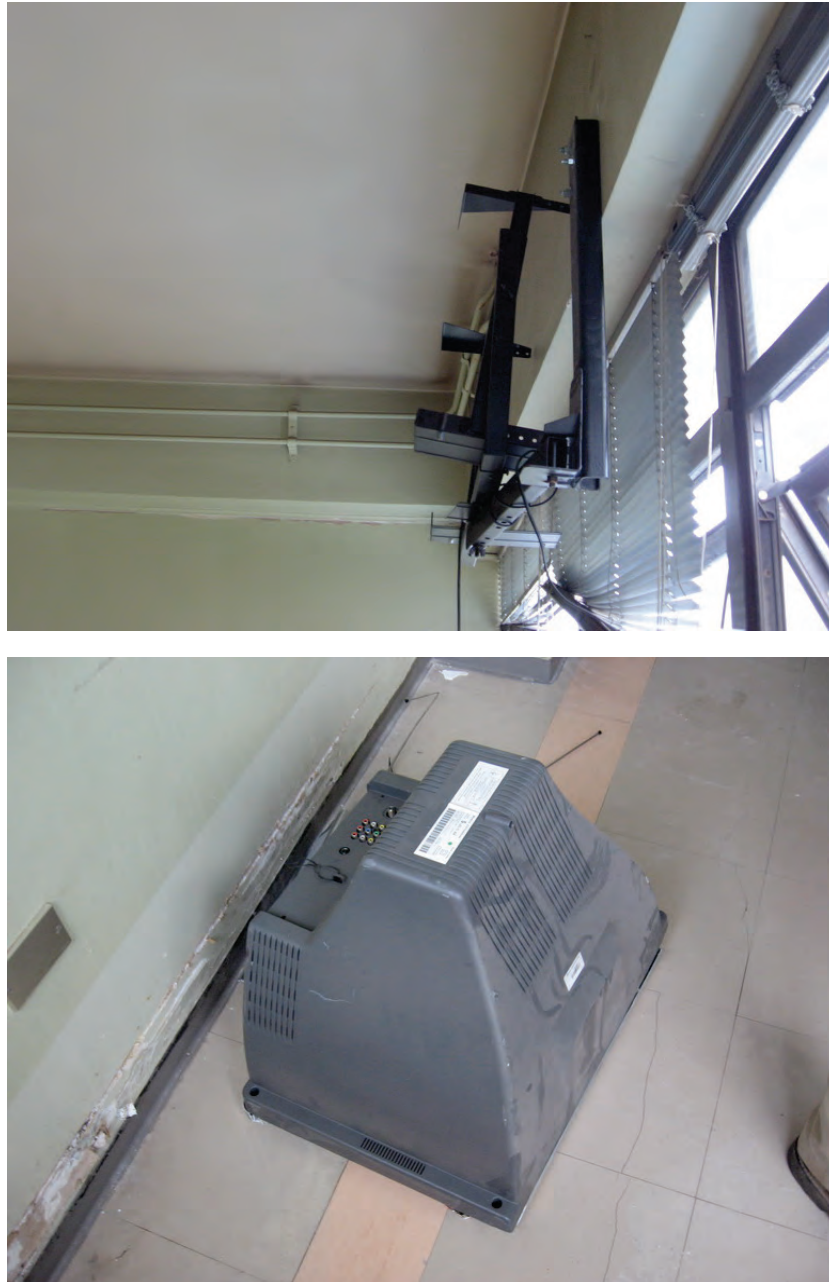
Figure 6.5.3.4-1 Wall-mounted monitor fell from the bracket in a hospital in the 2010 magnitude-8.8 Chile Earthquake; bracket still anchored to the wall (Photos courtesy of Rodrigo Retamales, Rubén Borosc hek & Associates)

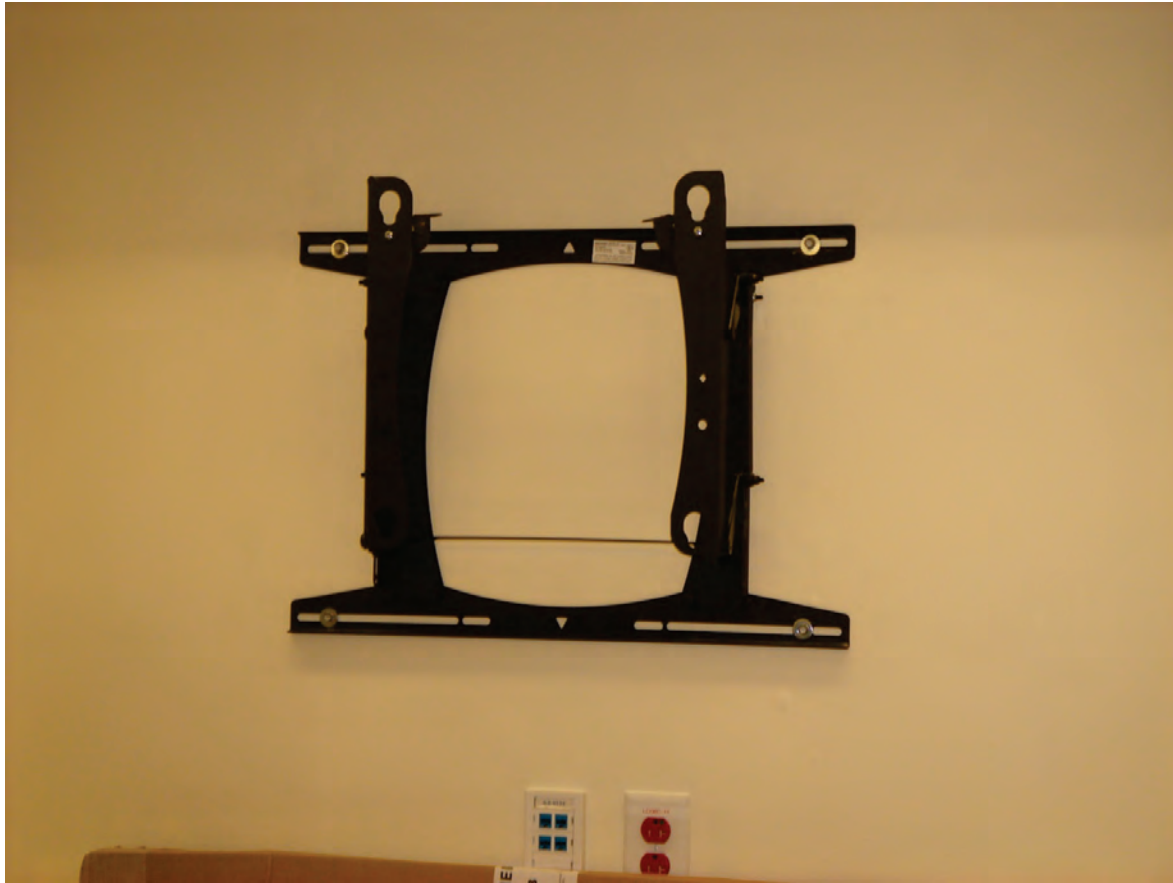
Figure 6.5.3.4-2 Wall-mounted television bracket anchored with sheet metal screws to wall studs at four locations. Bracket must be rated for the weight of television or monitor and that the unit must be securely attached to the bracket (Photo courtesy of Maryann Phipps, Estructure).

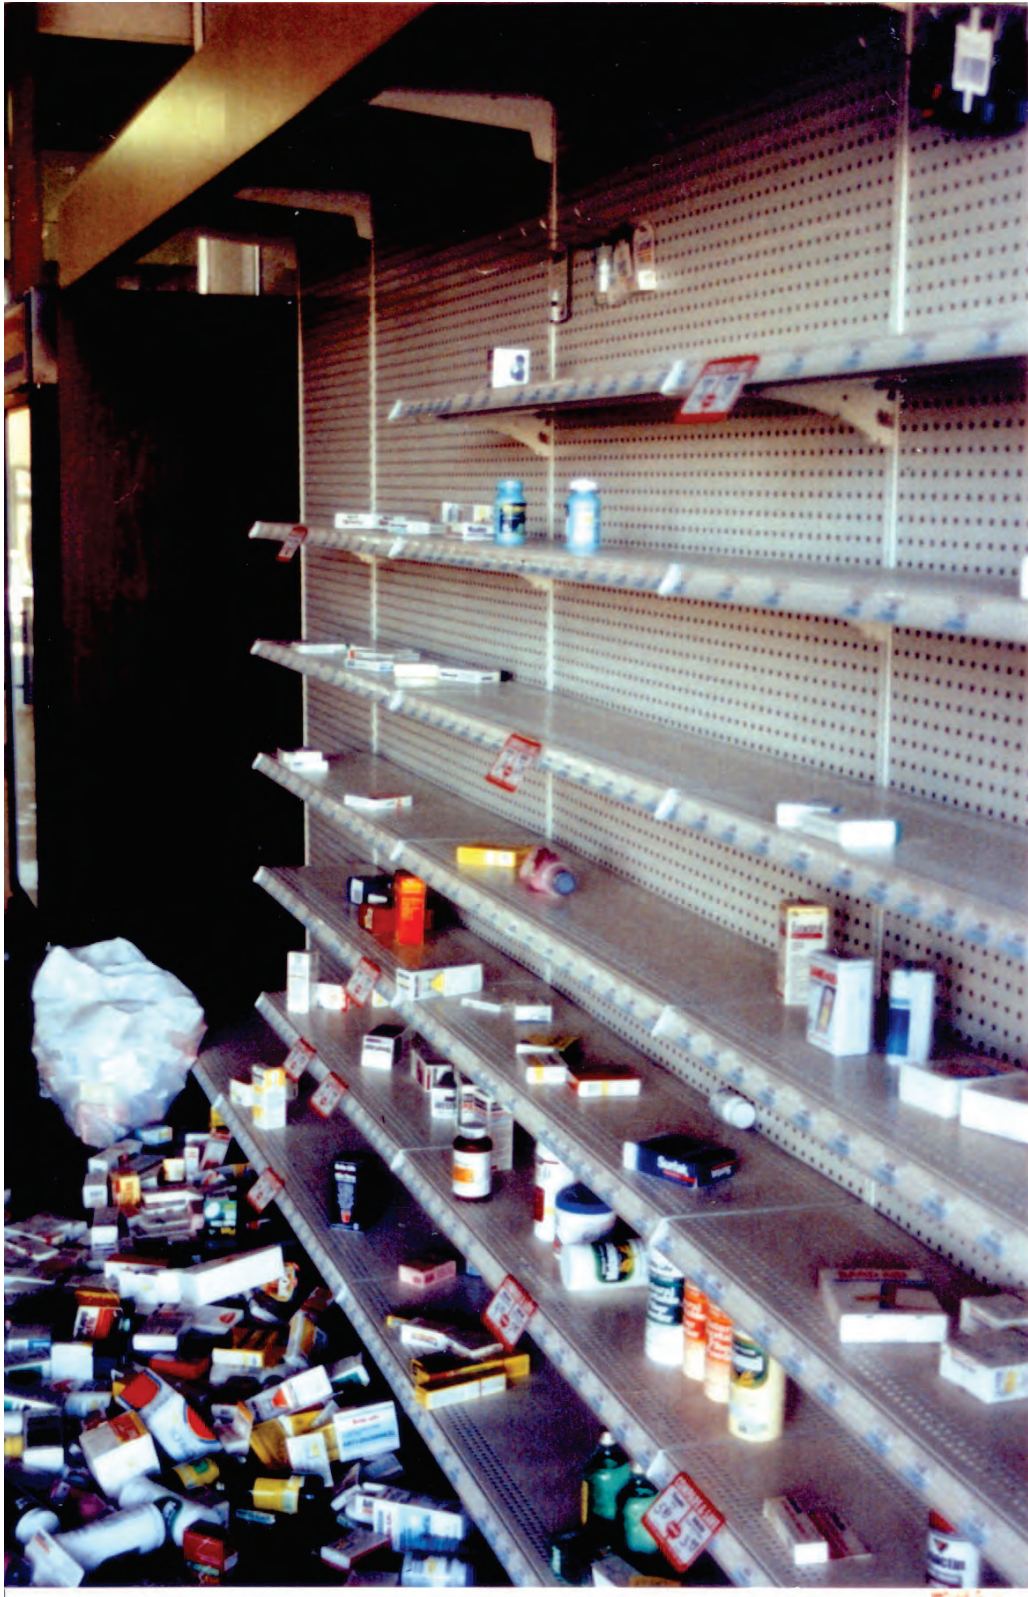
Figure 6.5.4.1-2 Spilled pharmaceutical and medical supplies in the 1994 magnitude-6.7 Northridge Earthquake (Photo courtesy of Robert Reitherman).

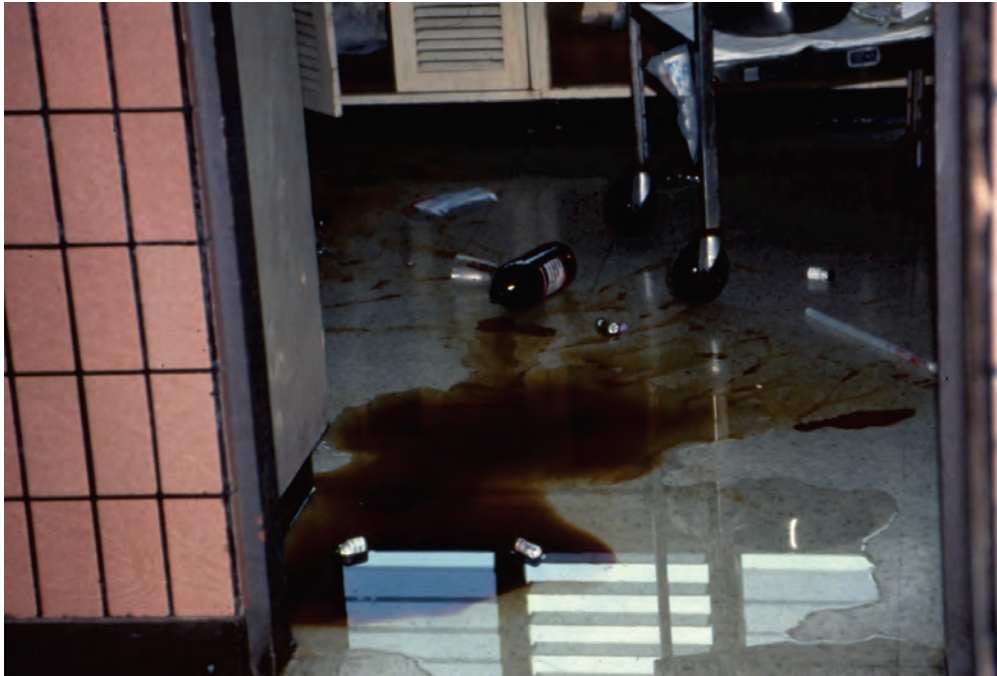
Figure 6.5.4.1-3 Spilled fluids in a hospital in the Costa Rica Earthquake (Photo courtesy of Degenkolb Engineers).

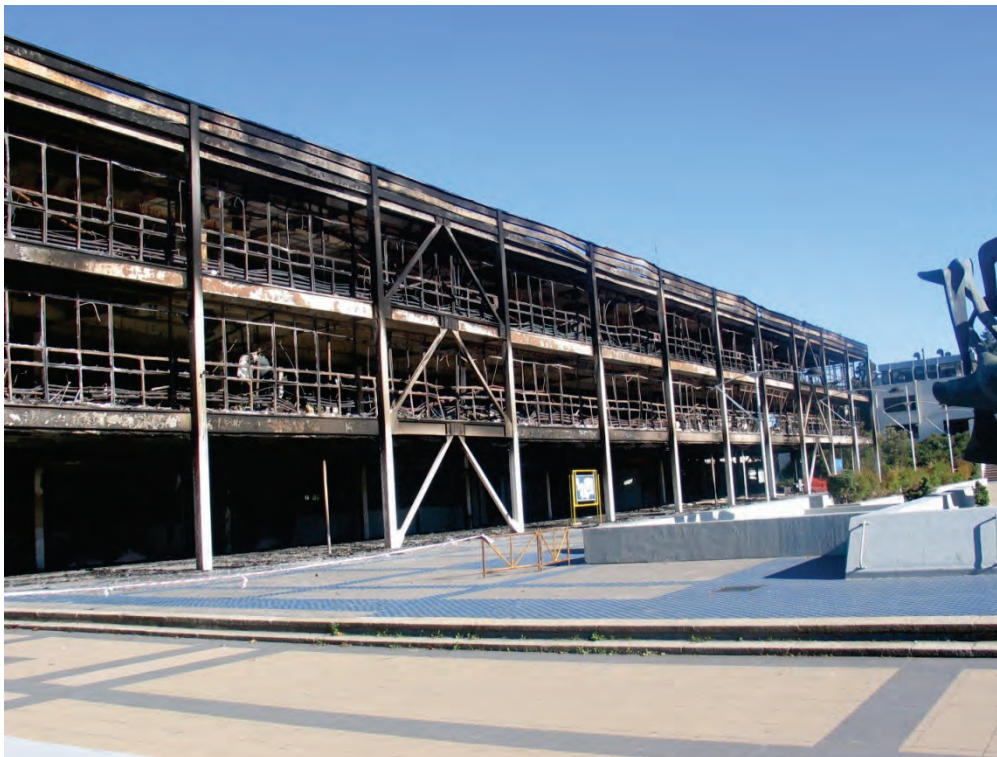
Figure 6.5.4.1-4 Fire destroyed the chemistry building containing the entire chemistry department at the University of Concepción in the 2010 magnitude-8.8 Chile Earthquake; fire exacerbated by the presence of hazardous chemicals (Photo courtesy of Bill Holmes, Rutherford & Chekene).

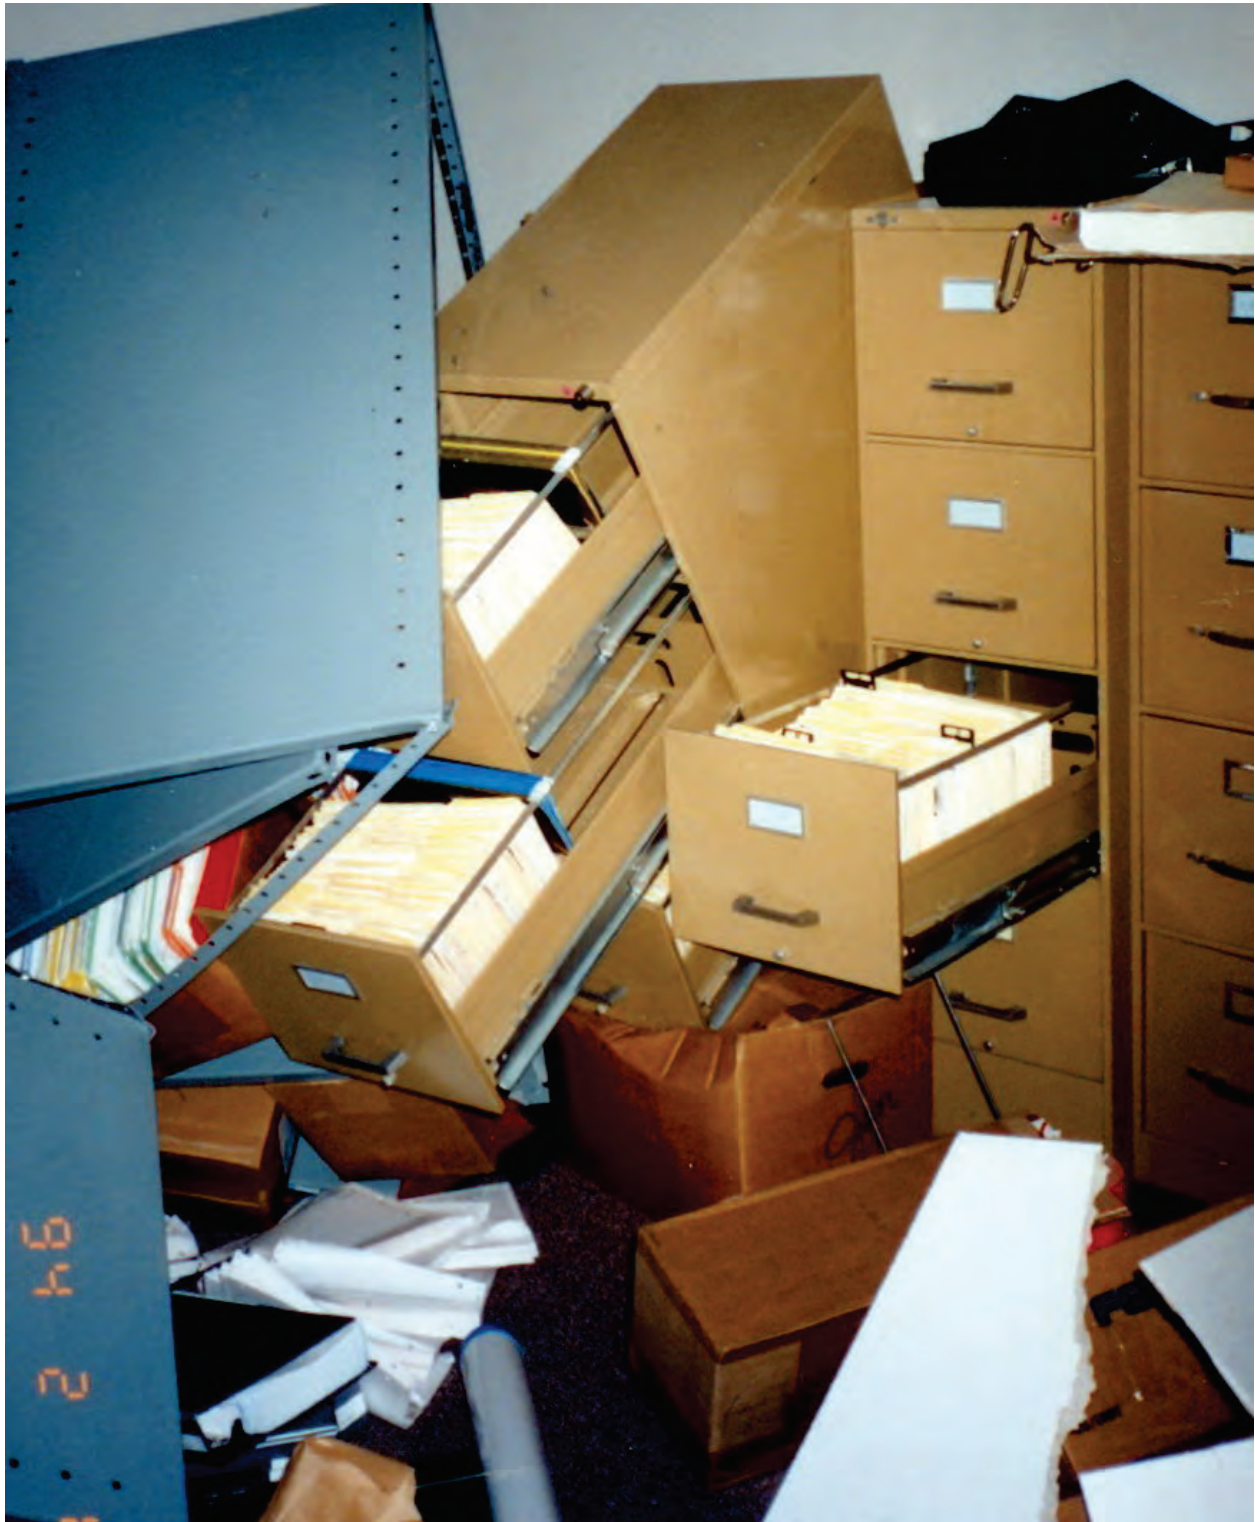
Figure 6.5.5.1-1 Failure of file cabinets in the 1994 magnitude-6.7 Northridge Earthquake (Photo courtesy of Wiss, Janney, Elstner Associates).

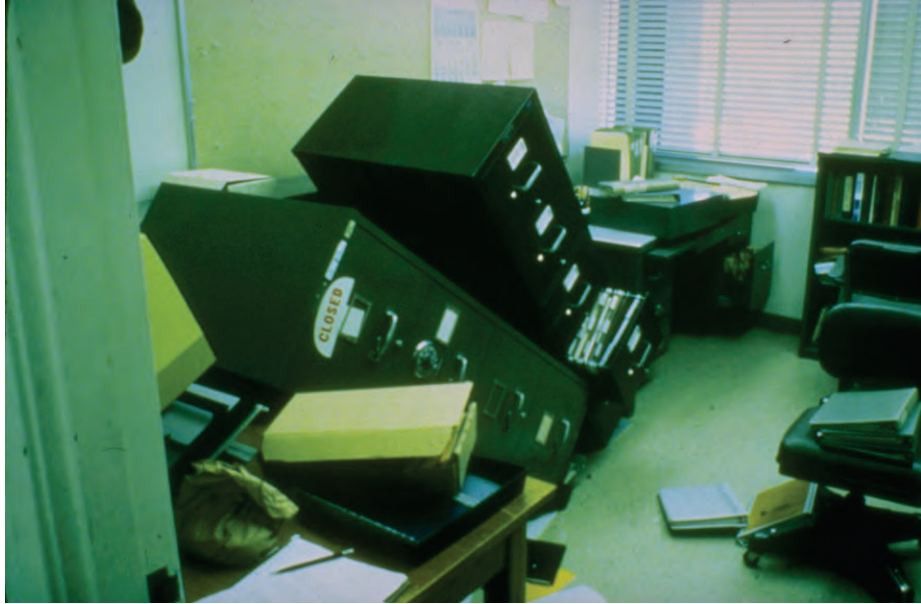
Figure 6.5.5.1-2 Tipped filing cabinets and other office equipment at the Lawrence Livermore Lab, California (NGDC, 2009).

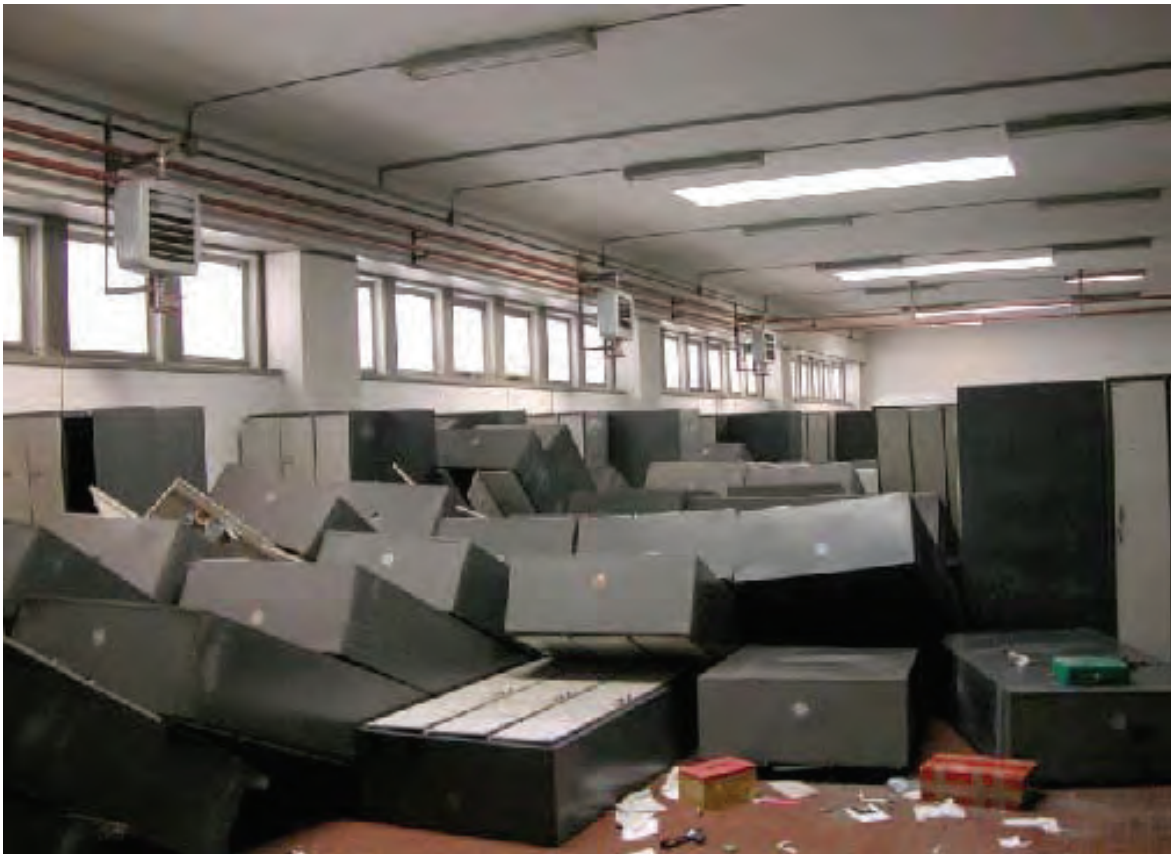
Figure 6.5.5.1-3 Unanchored cabinets toppled in the 1994 Northridge Earthquake (Photo courtesy of Wiss, Janney, Elstner)

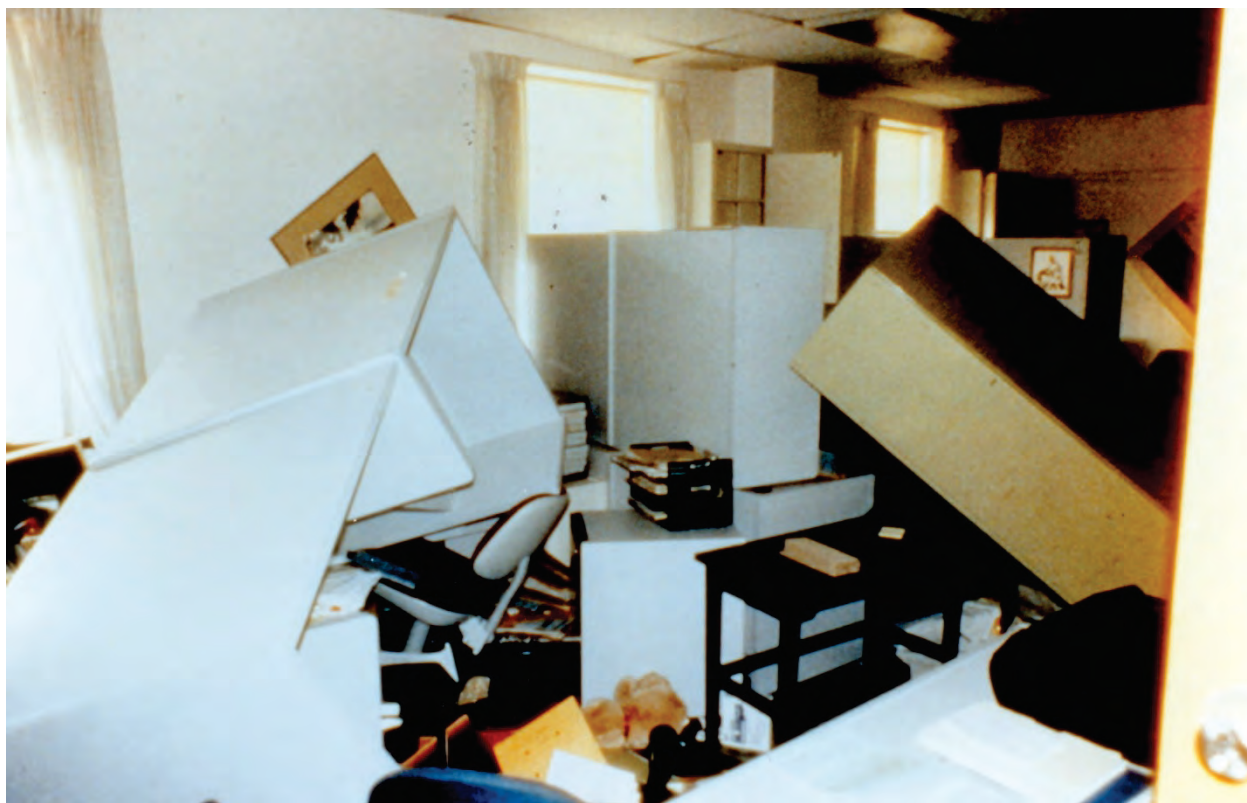
Figure 6.5.5.2-1 Damage to demountable partitions at the Veterans Administration Medical Center in Sepulveda as a result of the 1994 magnitude-6.7 Northridge Earthquake (Photo courtesy of James O. Malley).

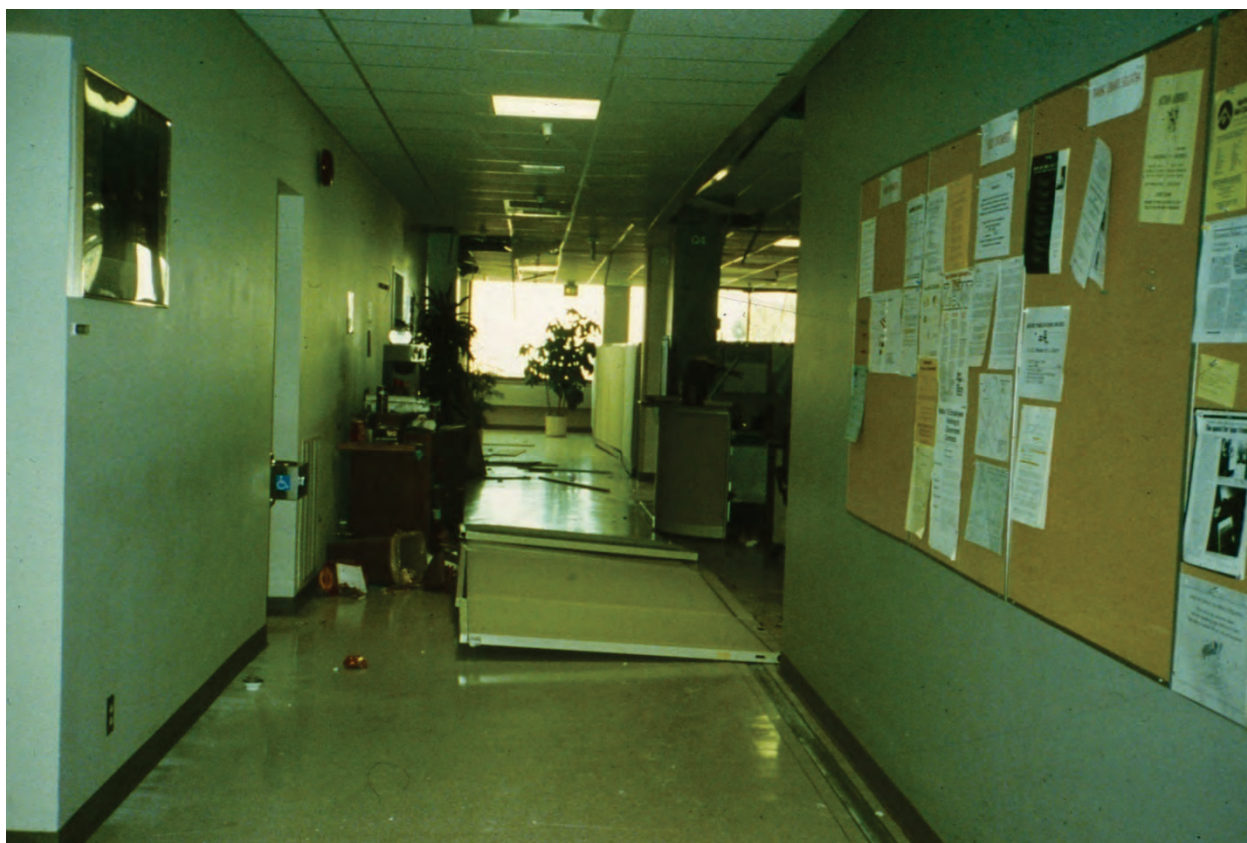
Figure 6.5.5.2-2 Damage to unbraced demountable partition in Silicon Valley office building in the 1989 magnitude-6.9 Loma Prieta Earthquake (Photo courtesy of Maryann Phipps, Estructure).

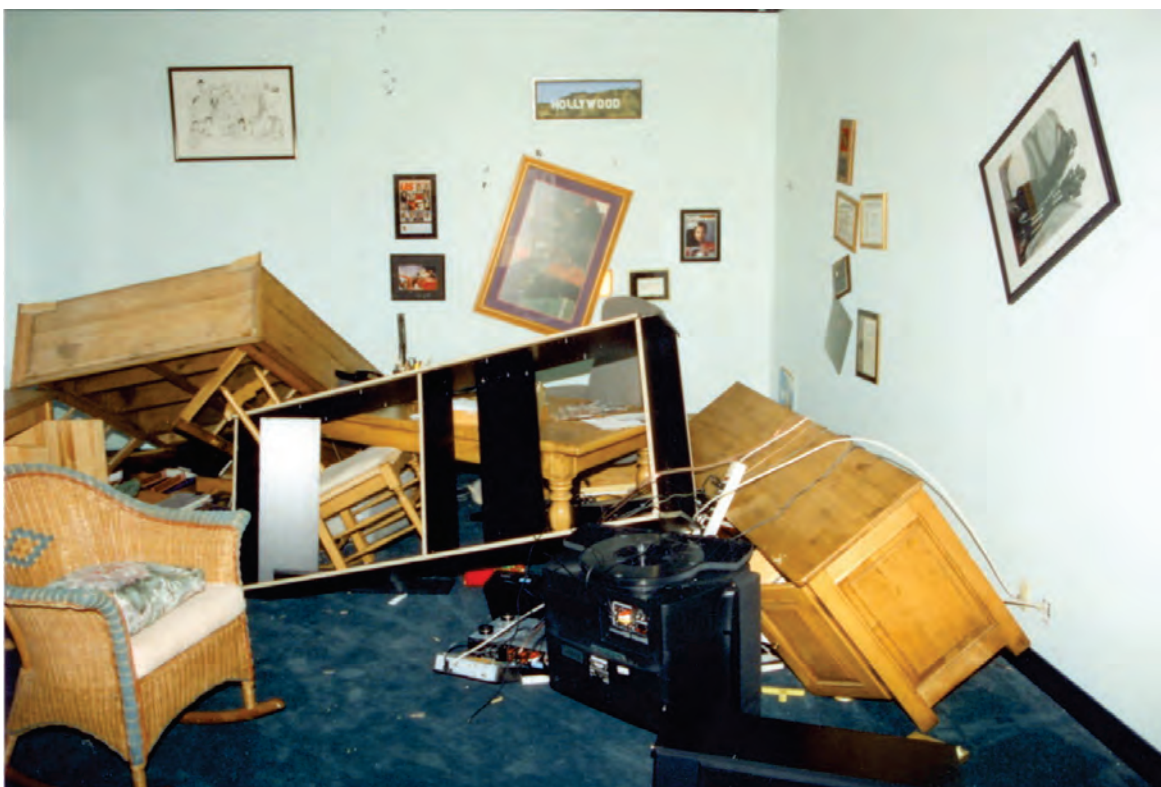
Figure 6.5.5.3-1 Residential damage in the 1994 magnitude-6.7 Northridge Earthquake (Photo courtesy of Wiss, Janney, Elstner Associates).

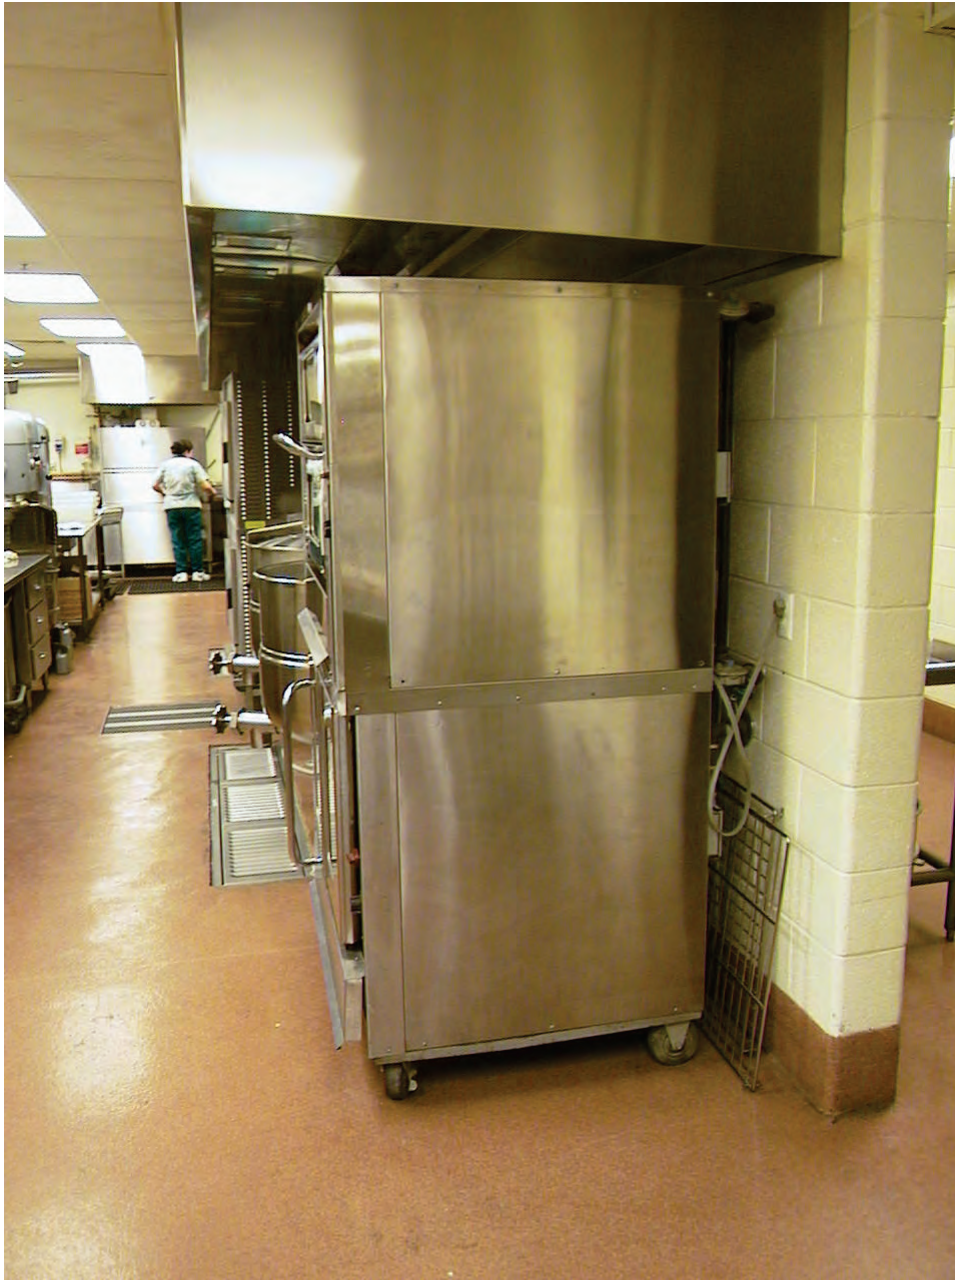
Figure 6.5.5.3-2 Existing condition: Unrestrained kitchen equipment (Photo courtesy of EQE for the Salt Lake City School District).

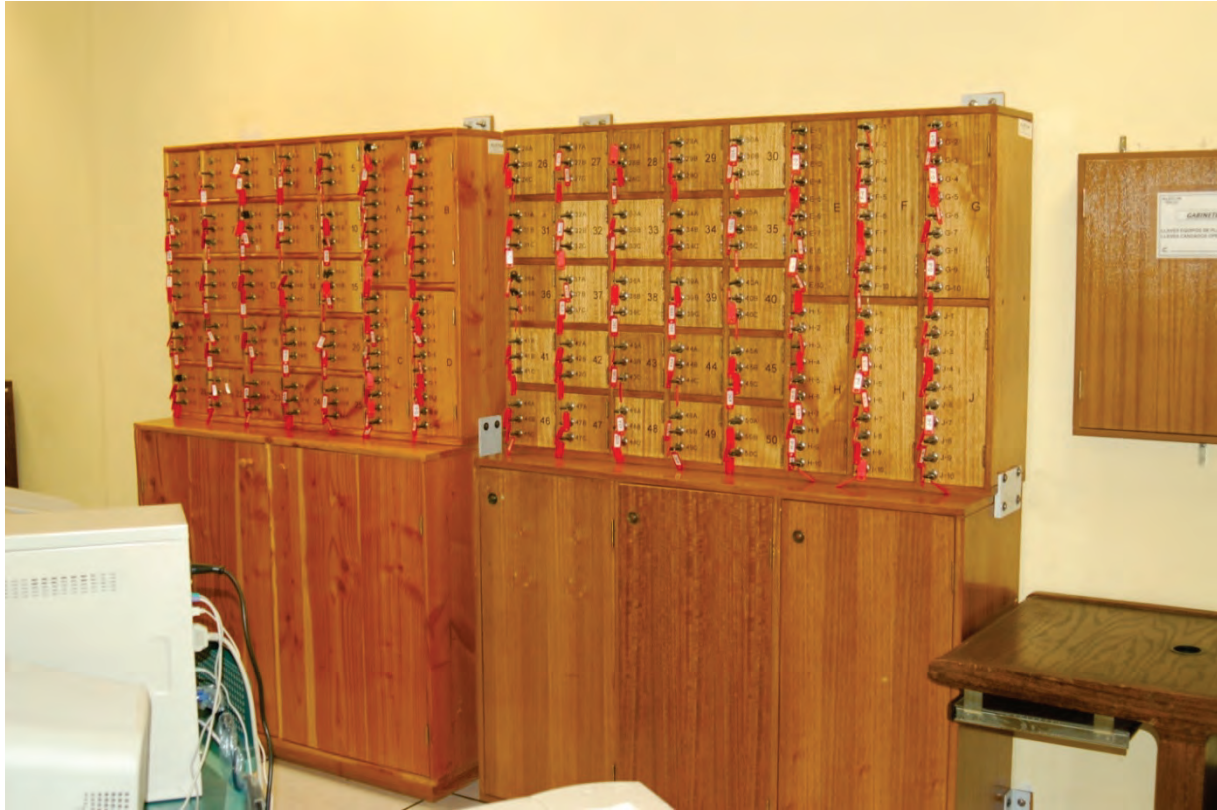
Figure 6.5.5.3-4 Anchored wood key cabinets in industrial plant control room; note top and bottom units anchored together and both anchored to wall (Photo courtesy of Eduardo Fierro, BFP Engineers).

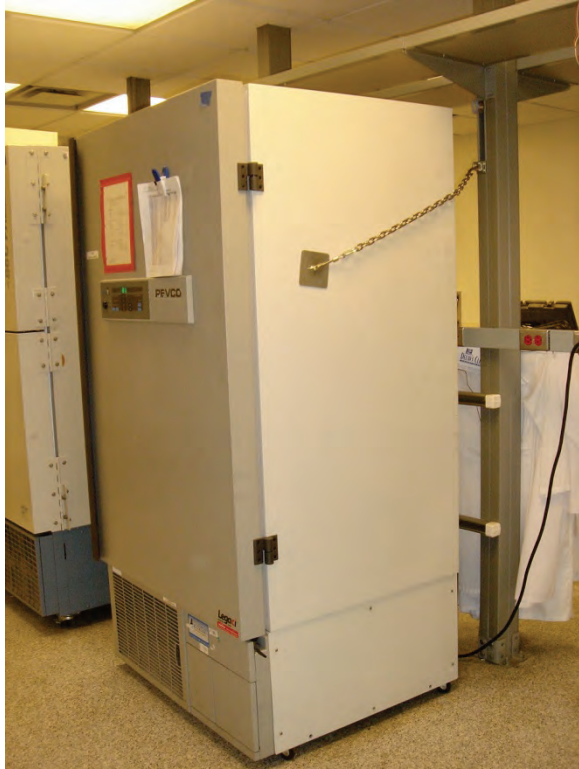
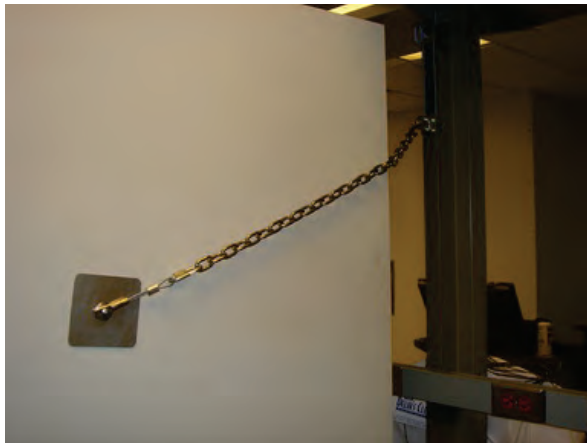
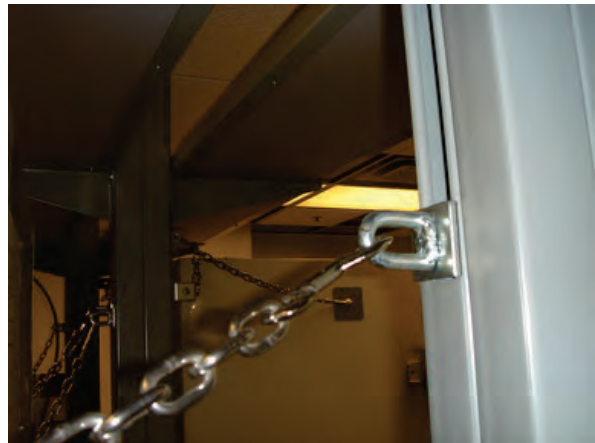
Figure 6.5.5.3-5 Typical tethering details for kitchen equipment and vending machines. Tether provided on both sides of equipment and does not penetrate the equipment housing (Photos courtesy of Maryann Phipps, Estructure).

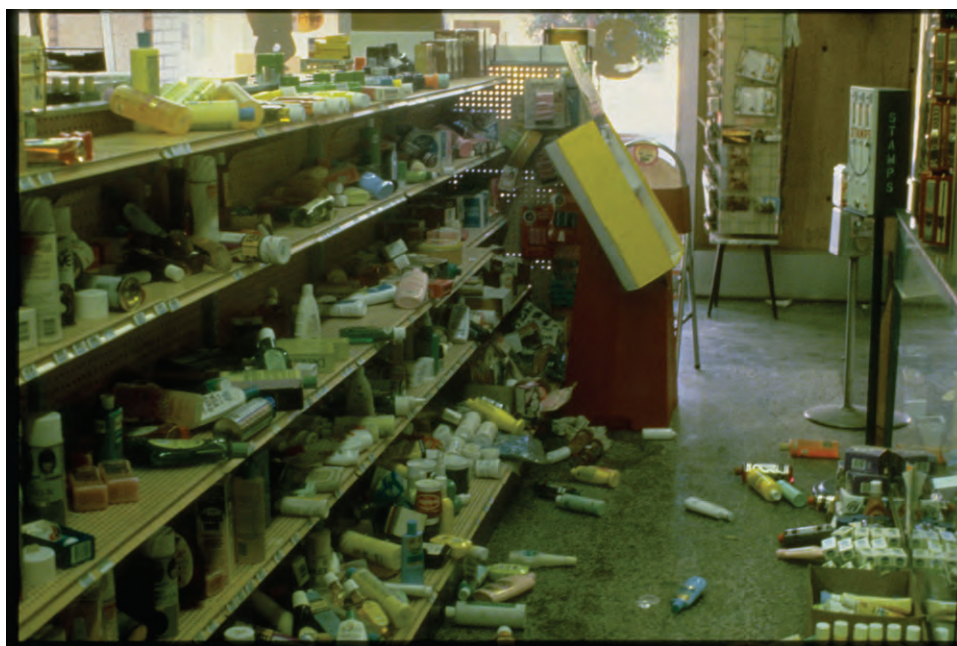
Figure 6.5.6.1-1 Merchandise fallen from drug store shelving in the 1979 magnitude-6.4 Imperial Valley Earthquake (NGDC, 2009).

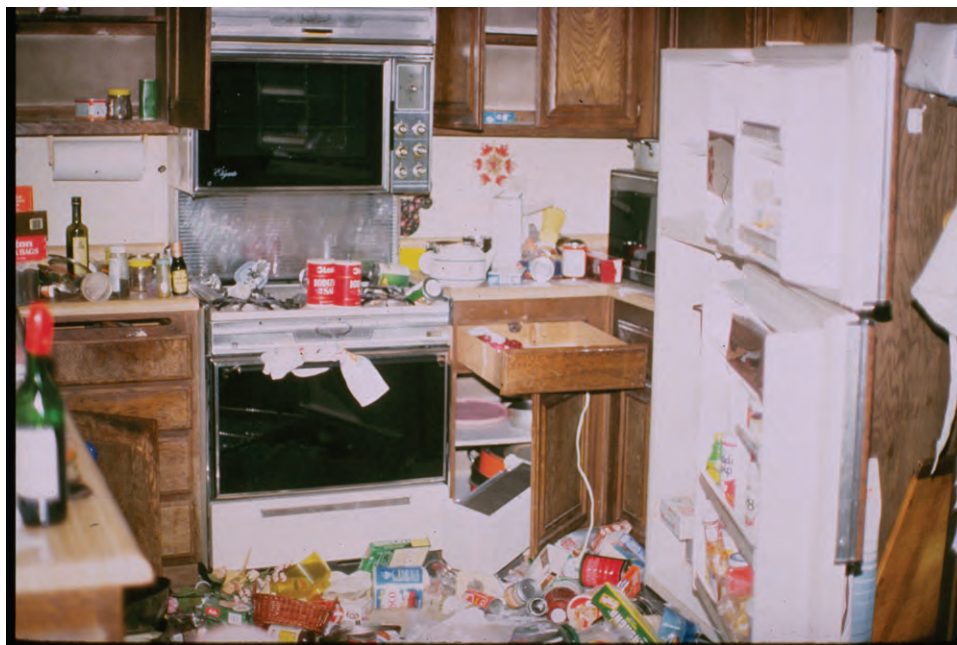
Figure 6.5.6.1-2 Items fallen from kitchen cabinets in townhouse near Northridge Fashion Center in the 1994 magnitude-6.7 Northridge Earthquake. An occupant cut her foot on glass when she ran into the kitchen area in the dark when the power was out (NGDC, 2009).

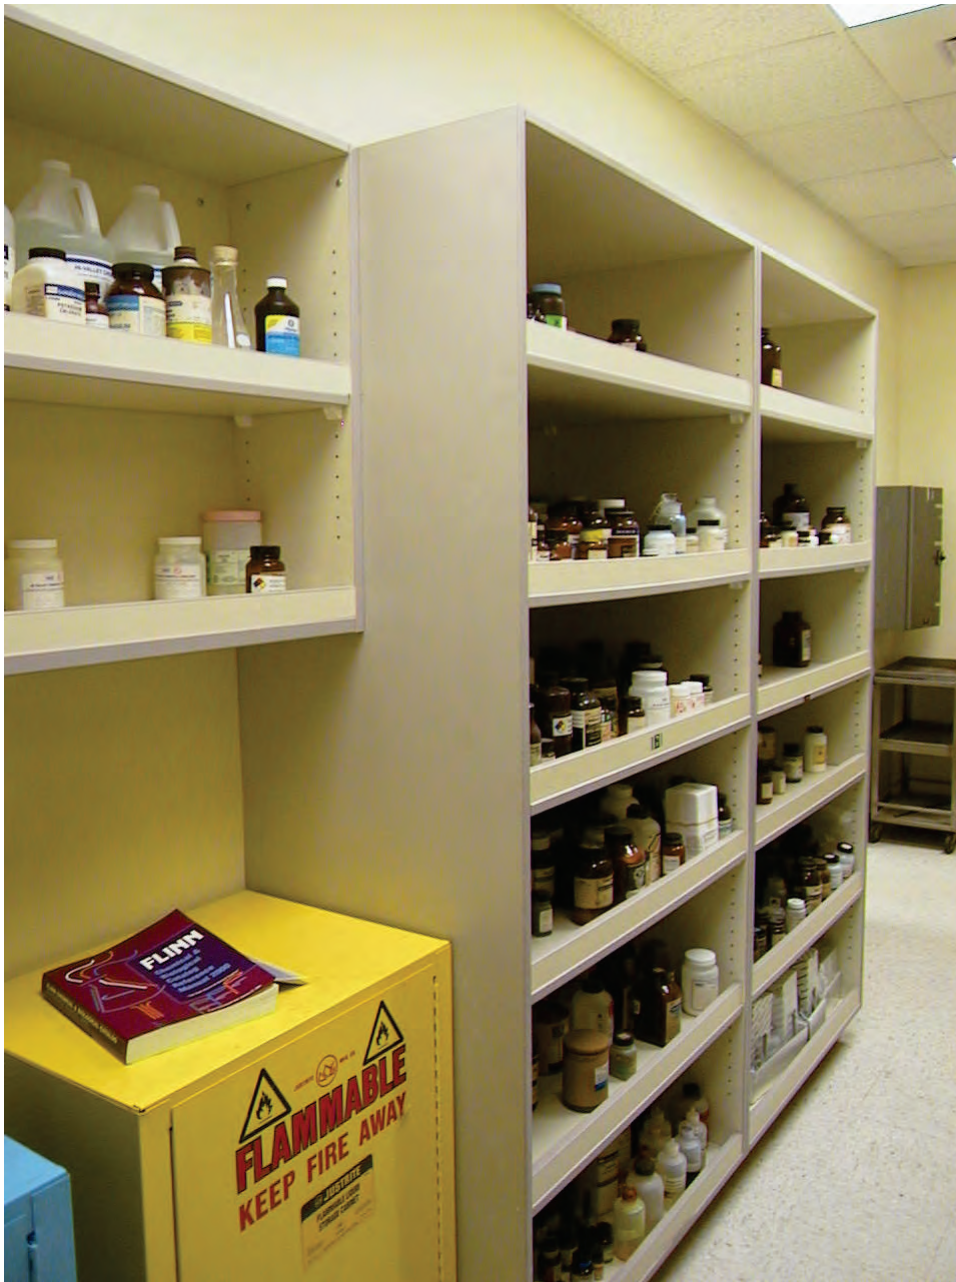
Figure 6.5.6.1-3 High school lab supplies protected on shelving with edge restraints (Photo courtesy of EQE for the Salt Lake City School District).

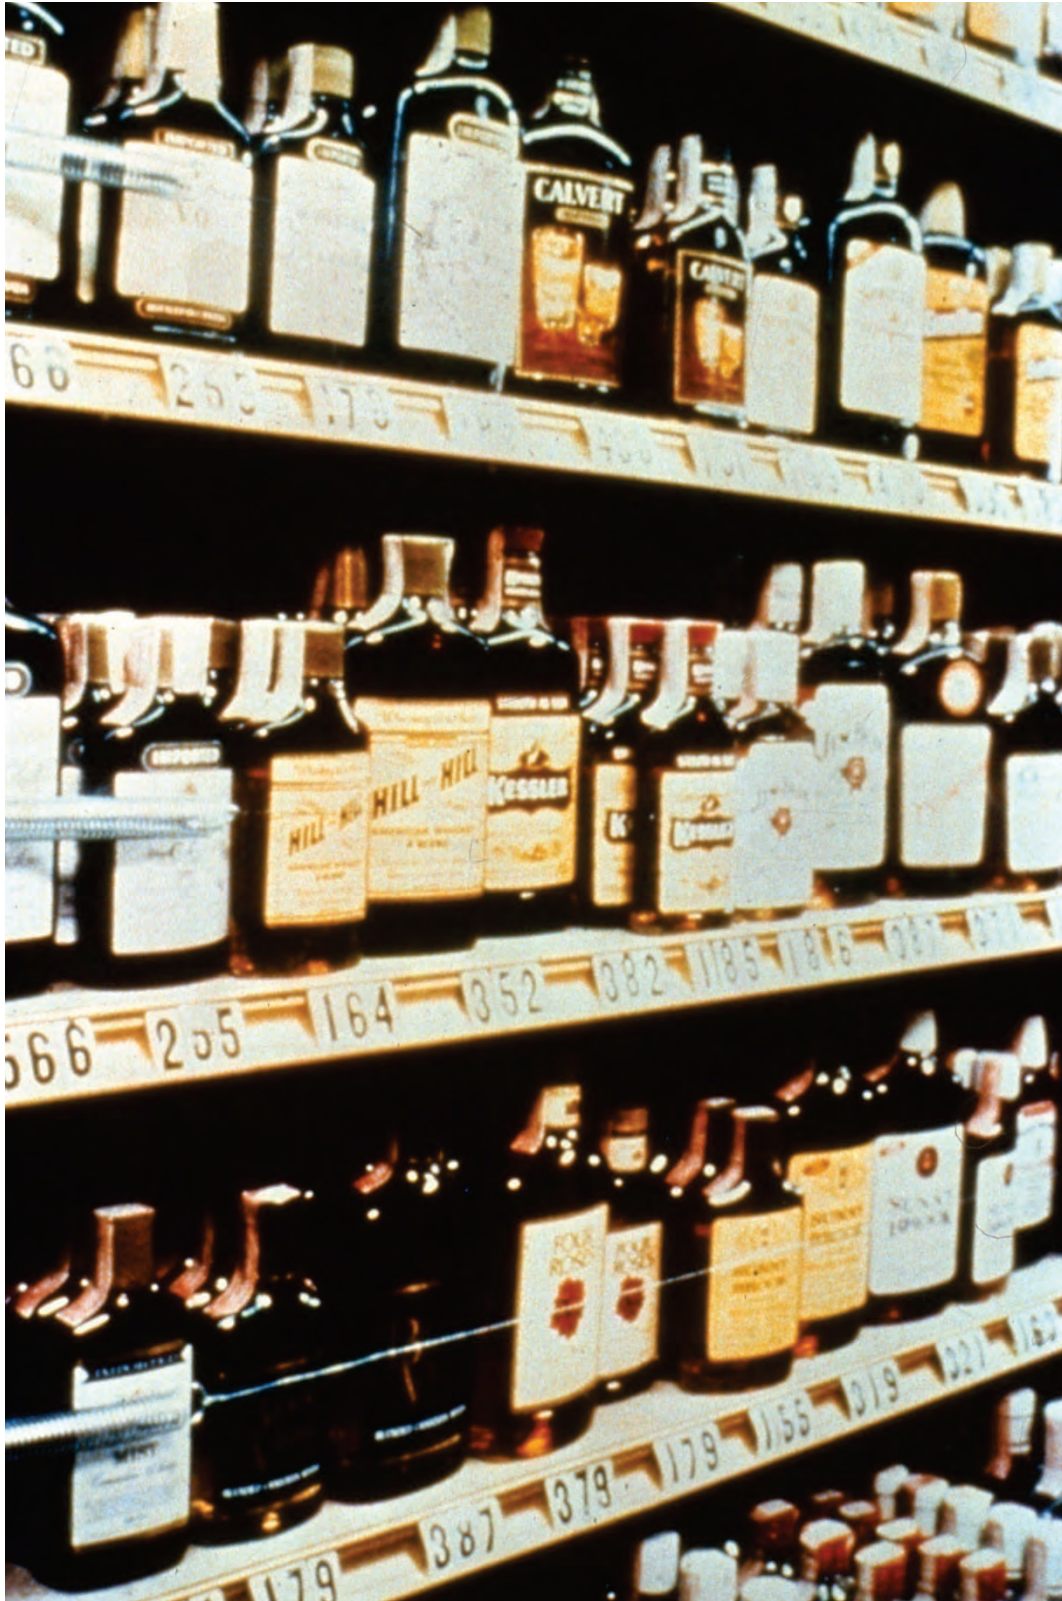
Figure 6.5.6.1-4 Shelf restraint example; shock cord made of wire and springs used to restrain liquor bottles (Photo courtesy of Robert Reitherman).

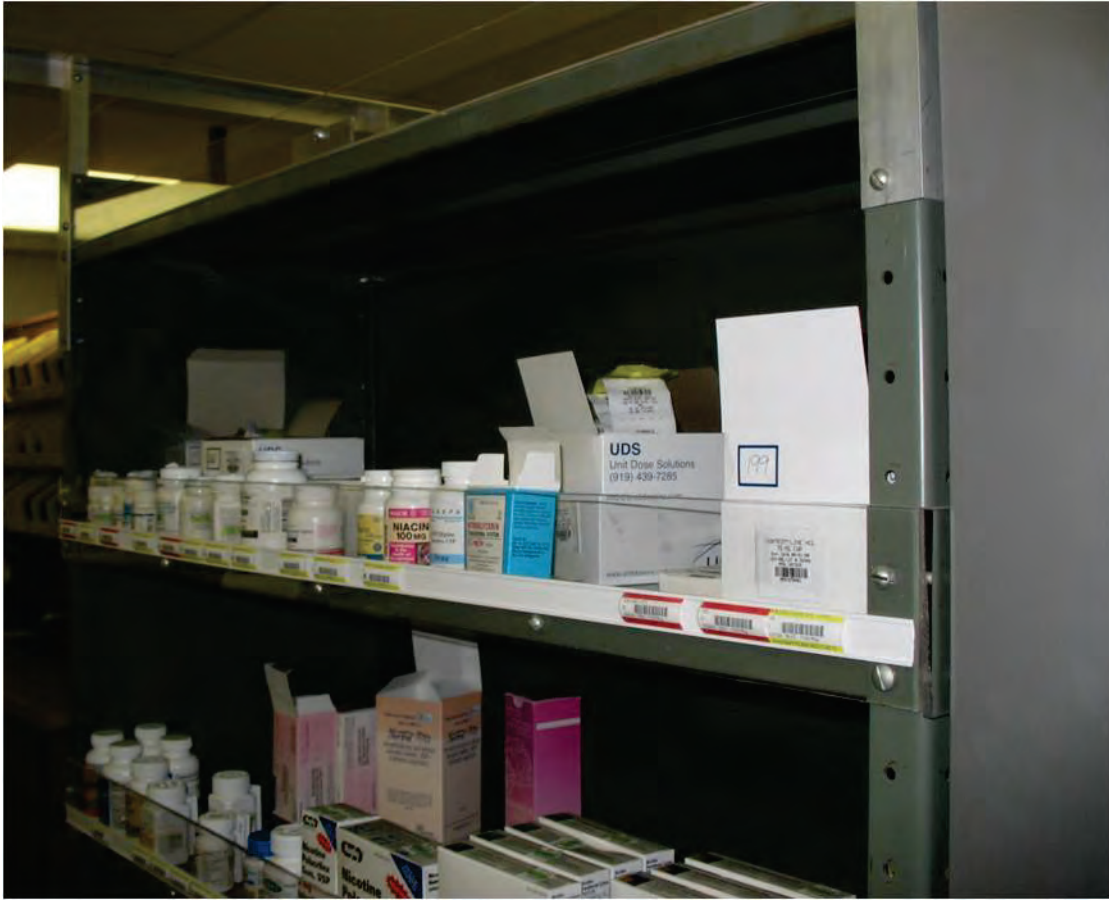
Figure 6.5.6.1-5 Plexiglass lip provides restraint for pharmaceuticals (Photo courtesy of Degenkolb Engineers).

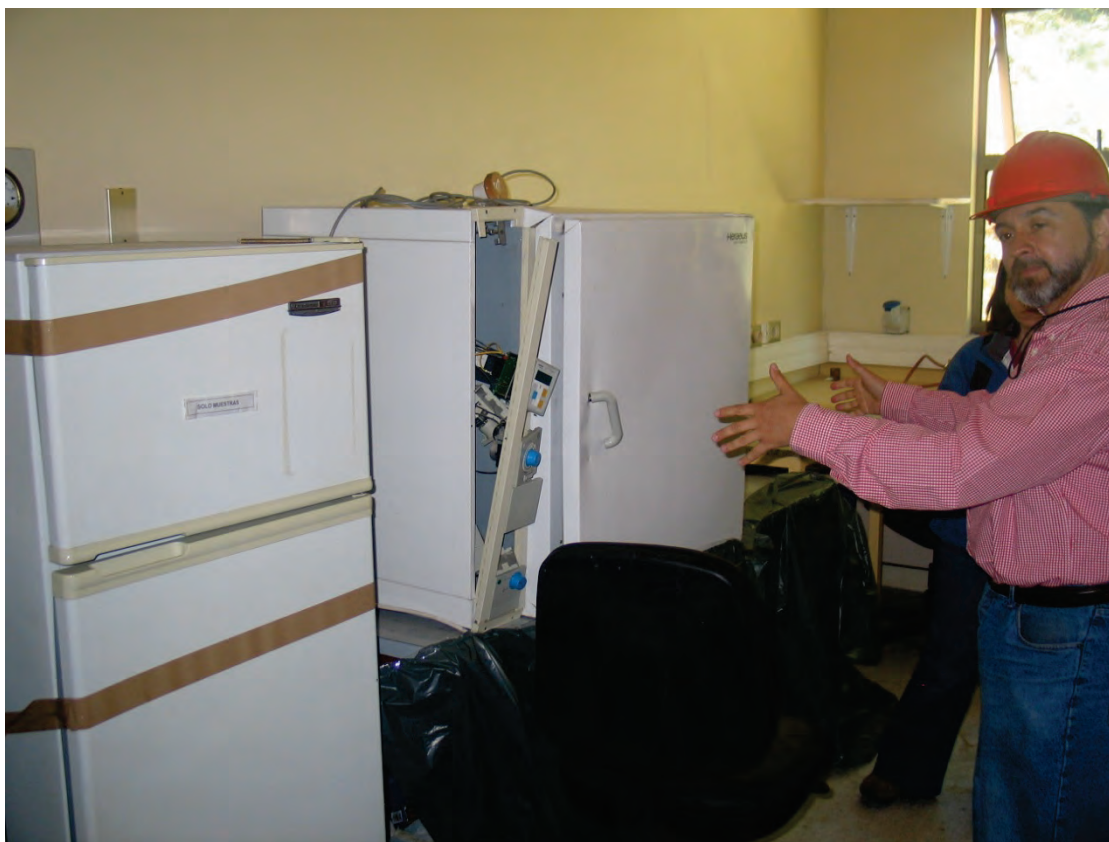
Figure 6.5.6.2-1 Incubator in the microbiology lab at the University of Concepción was ruined in the 2010 magnitude-8.8 Chile Earthquake (Photo courtesy of Bill Holmes, Rutherford & Chekene).

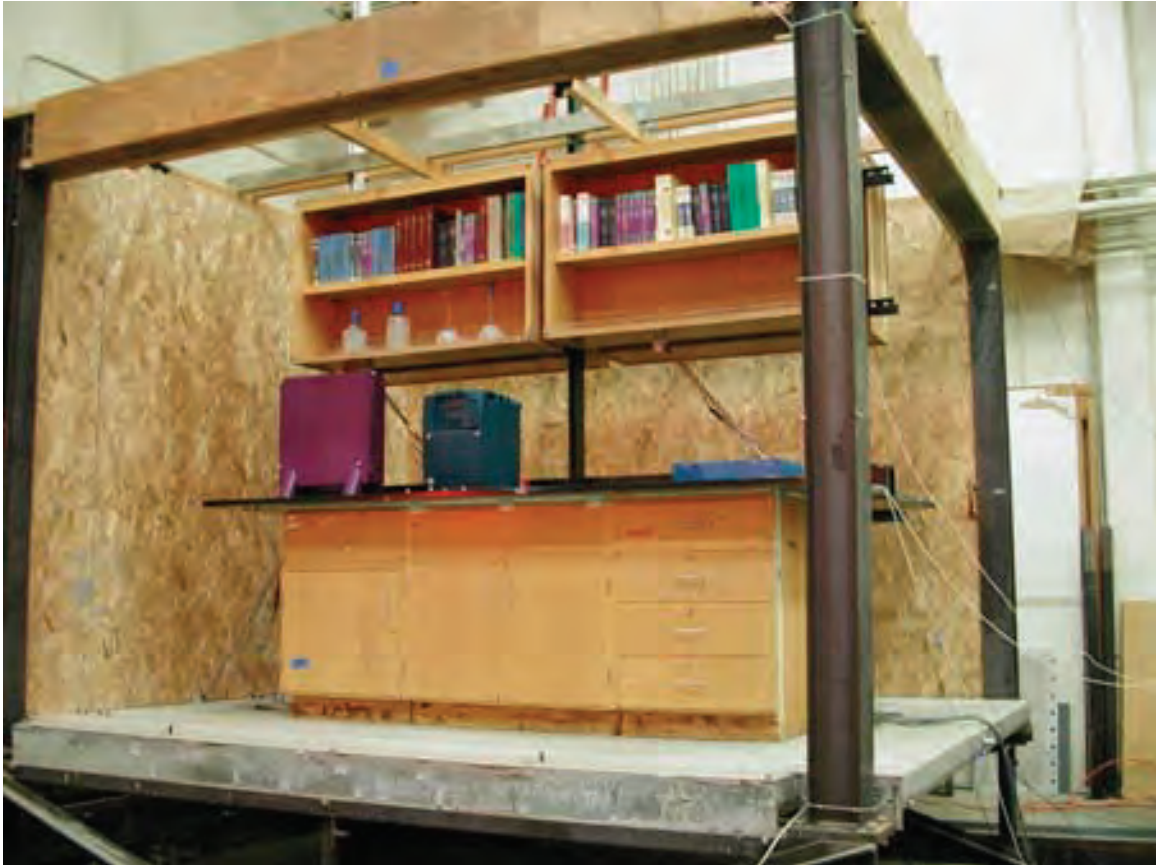
Figure 6.5.6.2-2 Set-up for shake table testing at UC Irvine of typical laboratory bench and shelving with countertop equipment and shelved books and supplies. Testing was done in order to develop fragility curves for use in developing performance based design parameters (PEER Testbed Study on a Laboratory Building: Exercising Seismic Performance Assessment; Comerio, Editor. PEER 2005/12).
