Reducing the Risks of Nonstructural Earthquake Damage – A Practical Guide

FEMA E-74 / December 2012

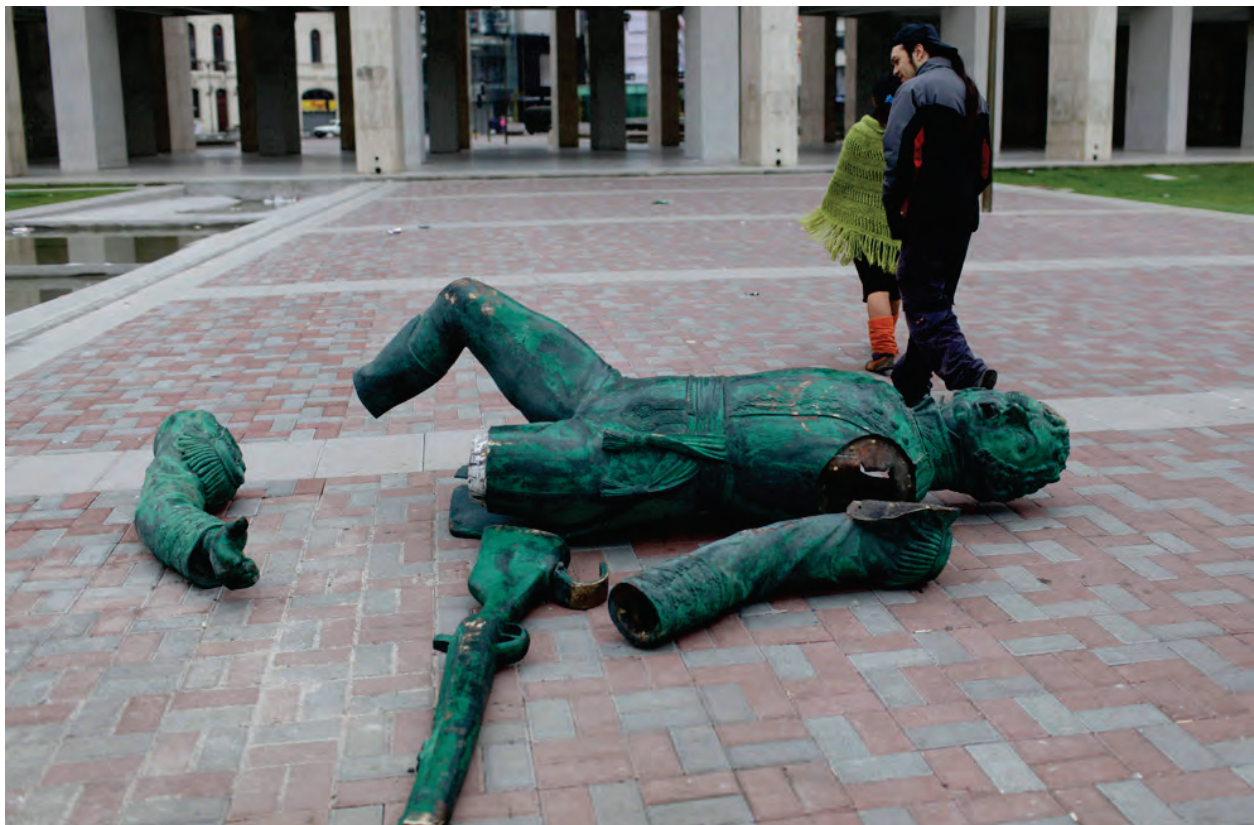
Figure 6.5.6.3-1 Fallen sculpture that collapsed in the 2010 Chile Earthquake (Photo by Natach Pisarenko, AP Photo).

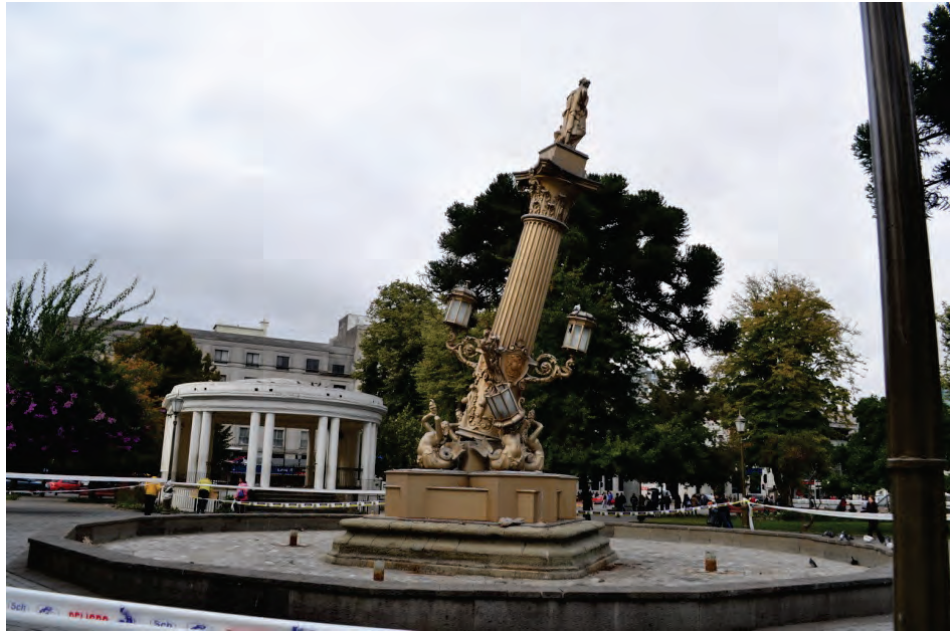
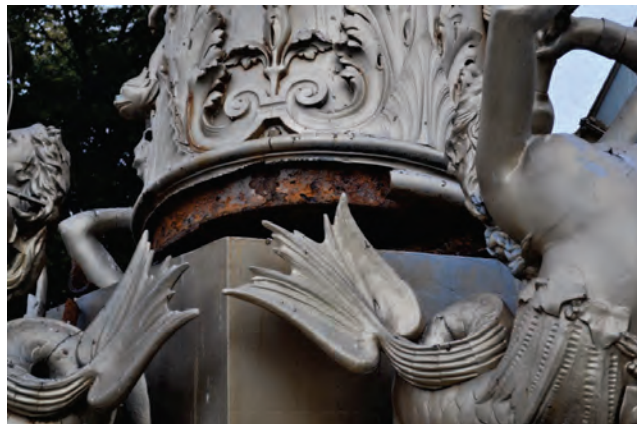
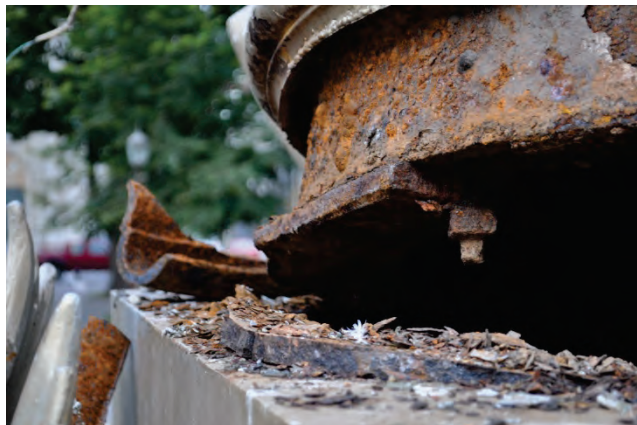
Figure 6.5.6.3-2 Leaning fountain after the 2010 Chile Earthquake; corrosion was a factor (Photos courtesy of Eduardo Fierro, BFP Engineers).

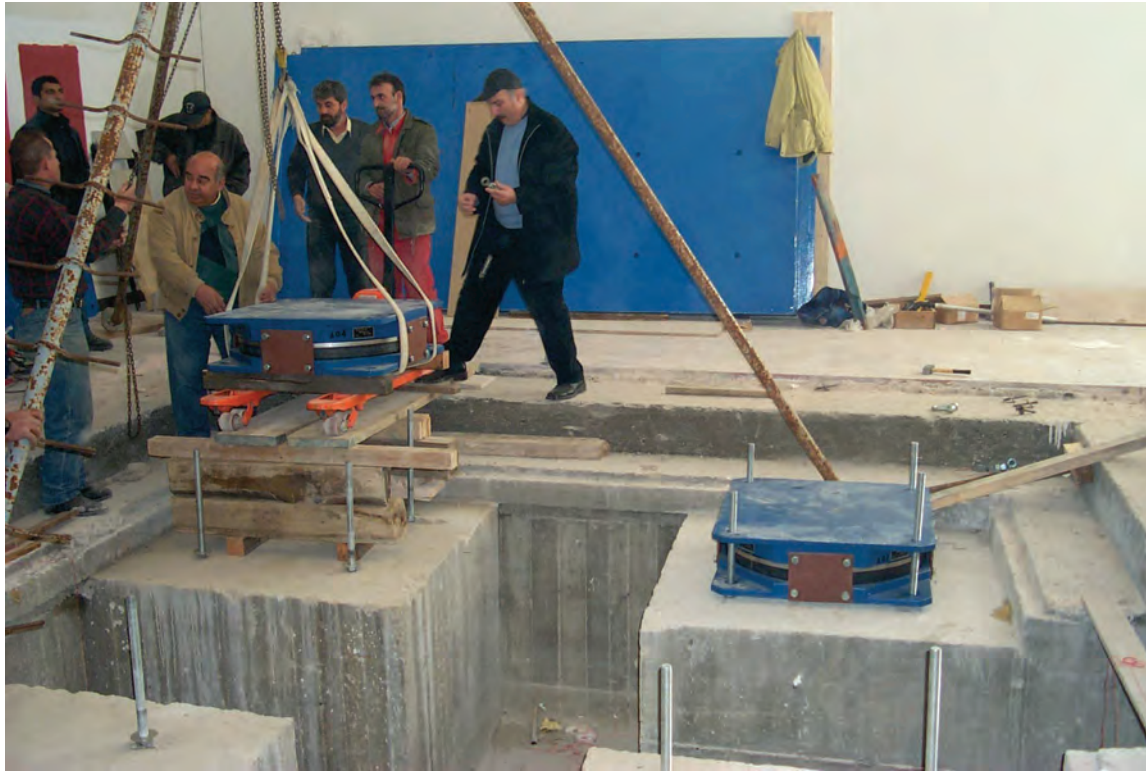
Figure 6.5.6.3-3b Installation of base isolation devices to support reinforced concrete slab for statue (Photo courtesy of University at Buffalo).

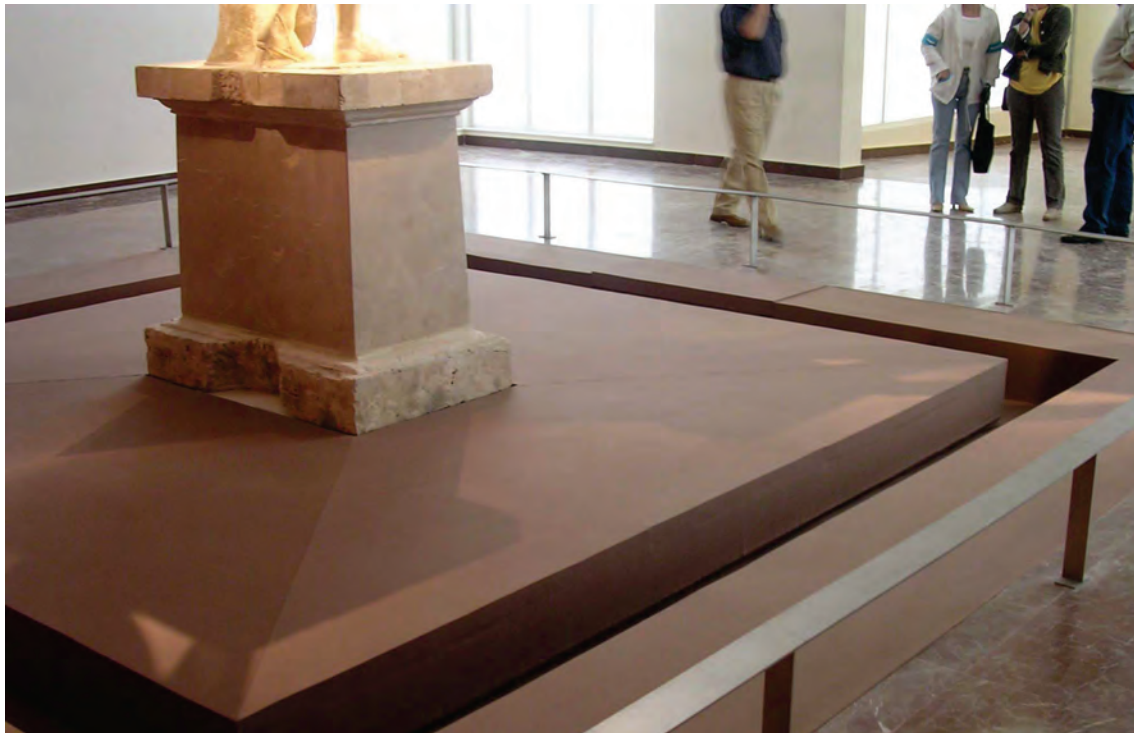
Figure 6.5.6.3-3c Completed installation of statue on platform with base isolation (Photo courtesy of University at Buffalo, SUNY).

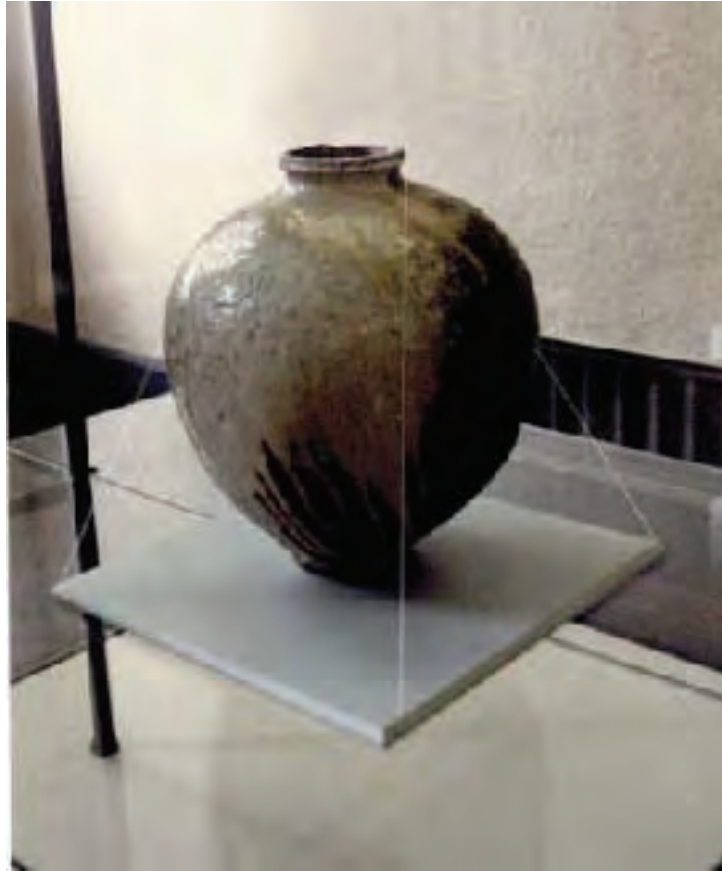
Figure 6.5.6.3-4 Seismic restraint of an object with artistic and historical value with nylon filament (fishing line) in the Tokyo Museum in Ueno Park (Photo courtesy of Robert Reitherman, CUREE).

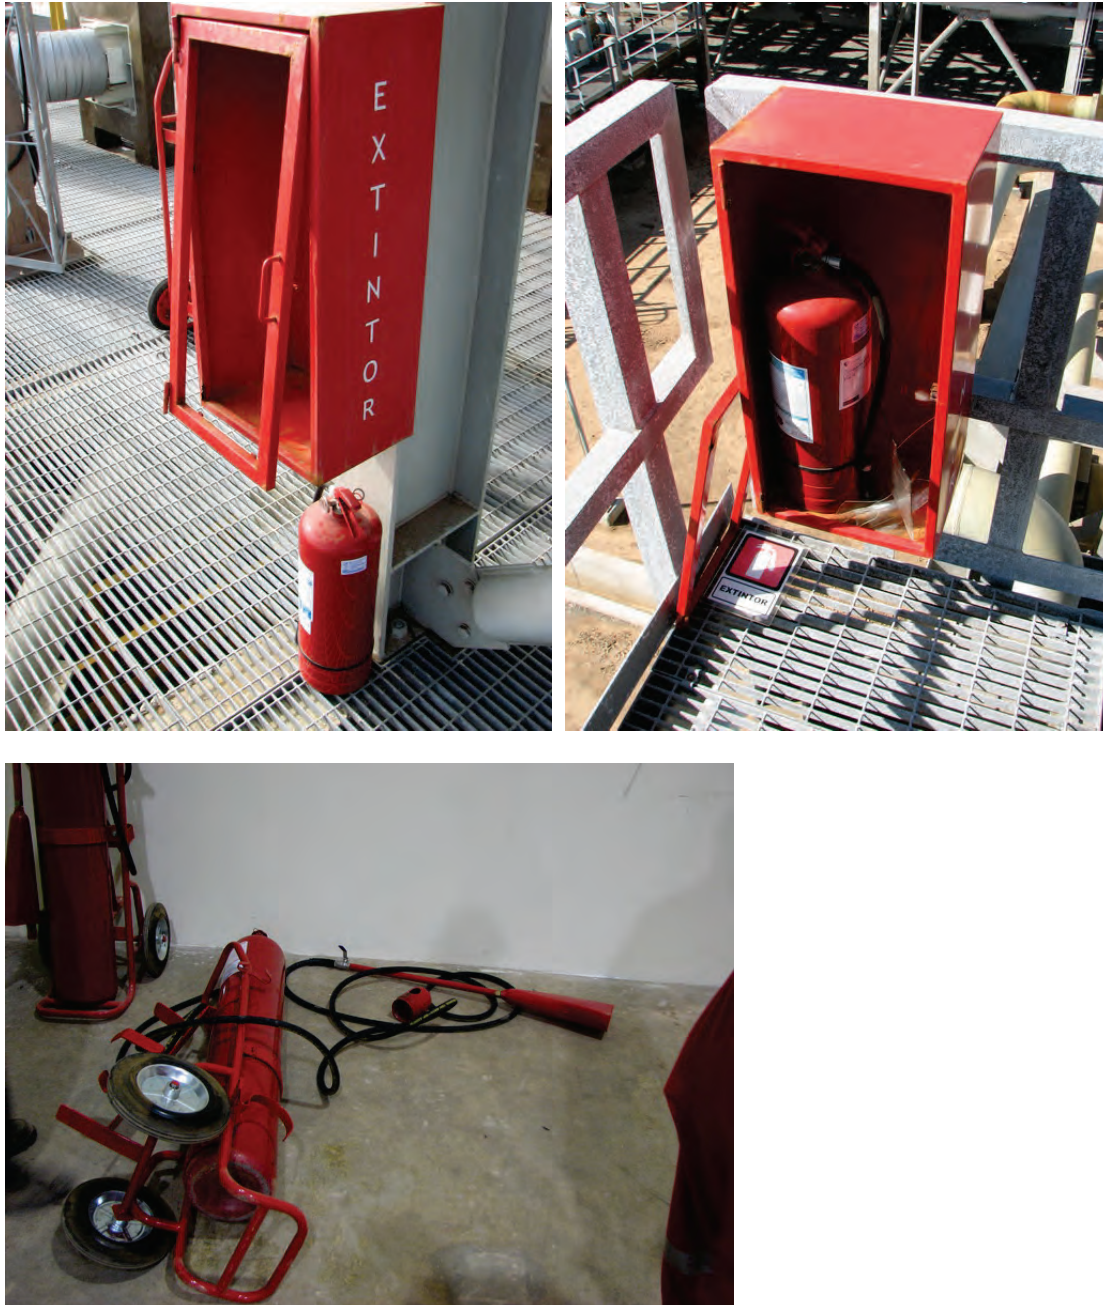
Figure 6.5.6.4-1 Fire extinguishers damaged during the 2010 magnitude-8.8 Chile Earthquake at an industrial facility (Photos courtesy of Antonio Iruretagoyena, Rubén Boroschek & Associates).
