Design Guide

for Improving Critical Facility Safety
from Flooding and High Winds

FEMA 543 / January 2007

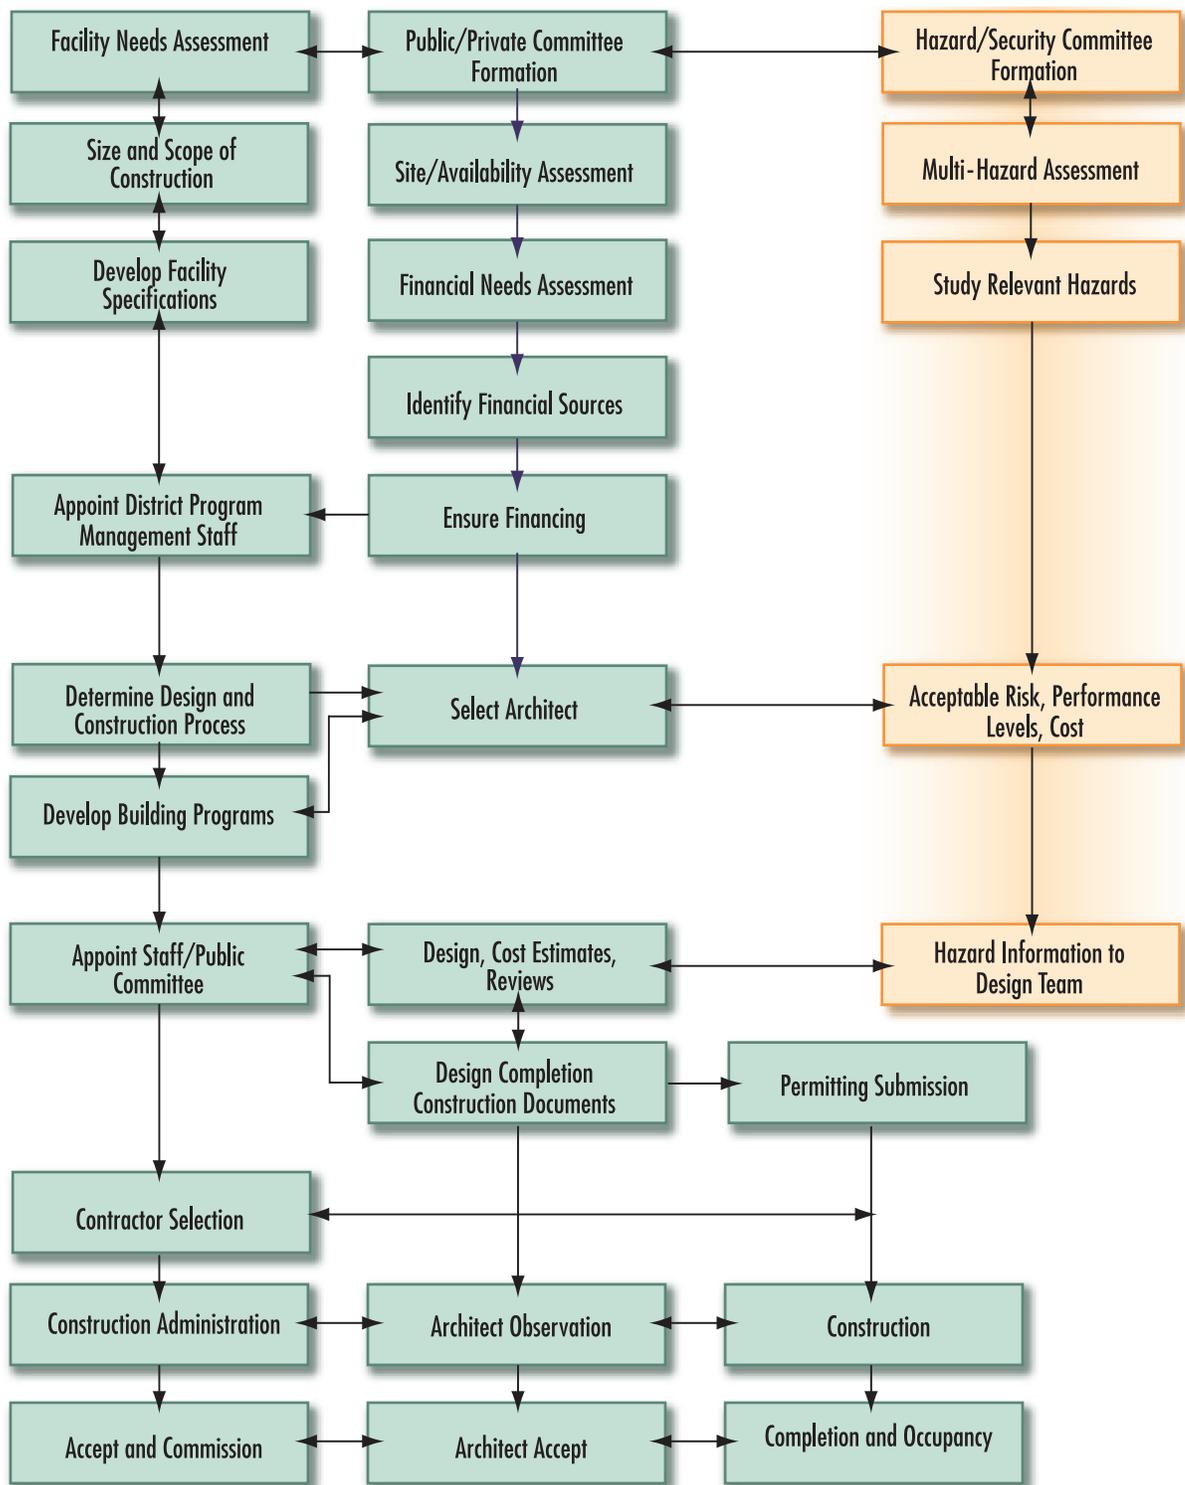
Figure 1-3: Process flow chart for decisionmakers

The sequence of the above steps may vary, depending on the complexity of the program; some steps may be implemented simultaneously. Figure 1-3 shows a flow chart of this typical process. Also shown (in the five boxes to the right) are specific activities related to designing for multiple hazards and how these activities fit into the construction process.

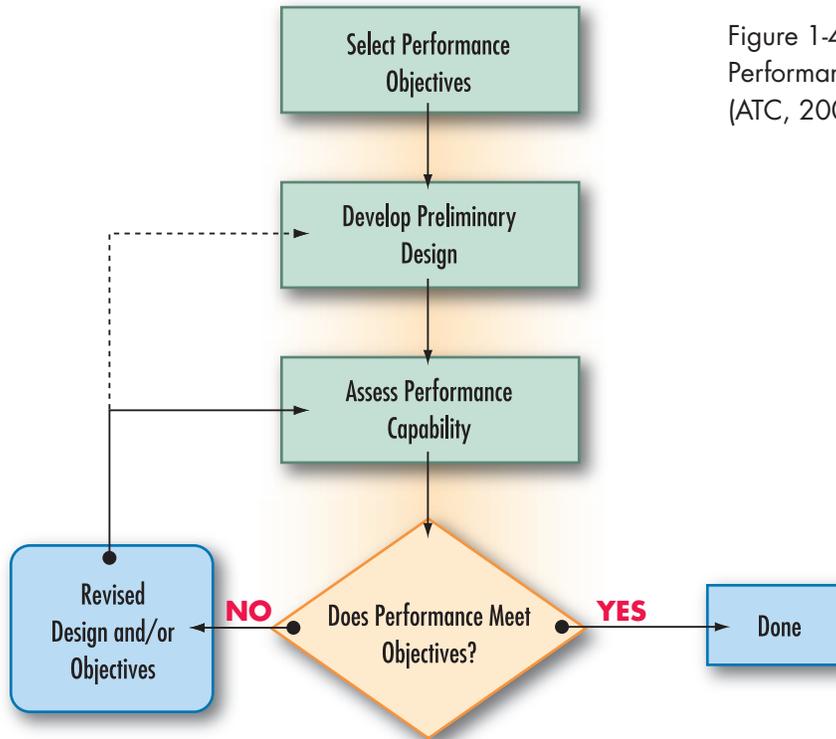
Figure 1-4:
Performance-based design flow diagram
(ATC, 2003)

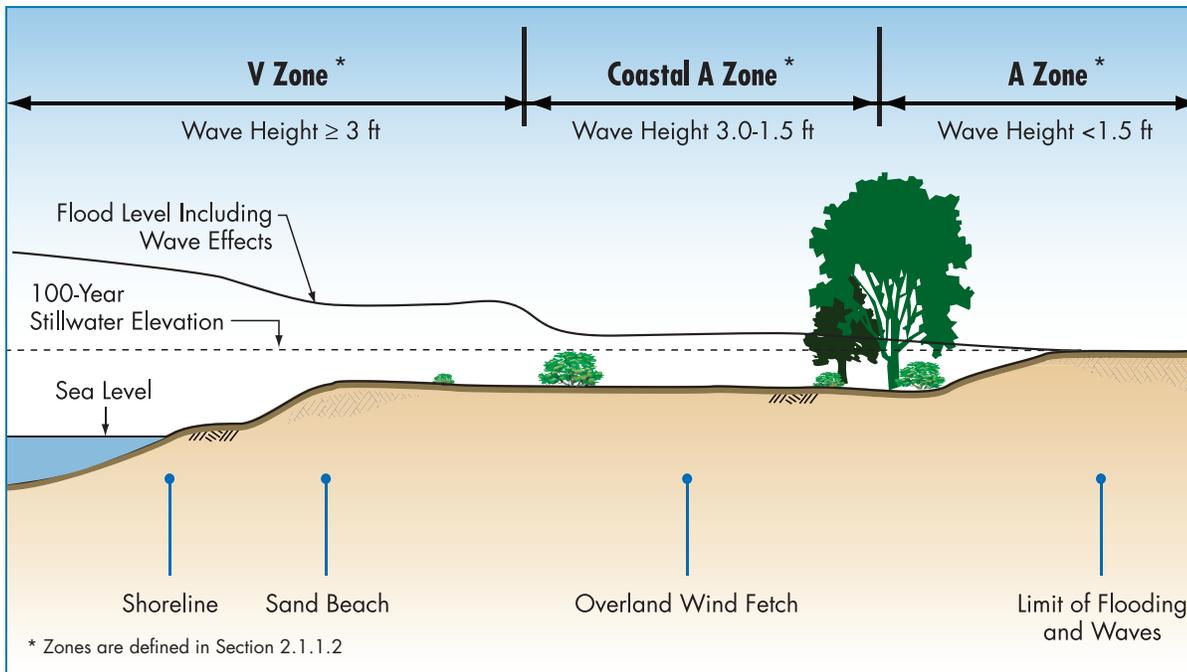
Figure 2-2: The floodplain along an open coast

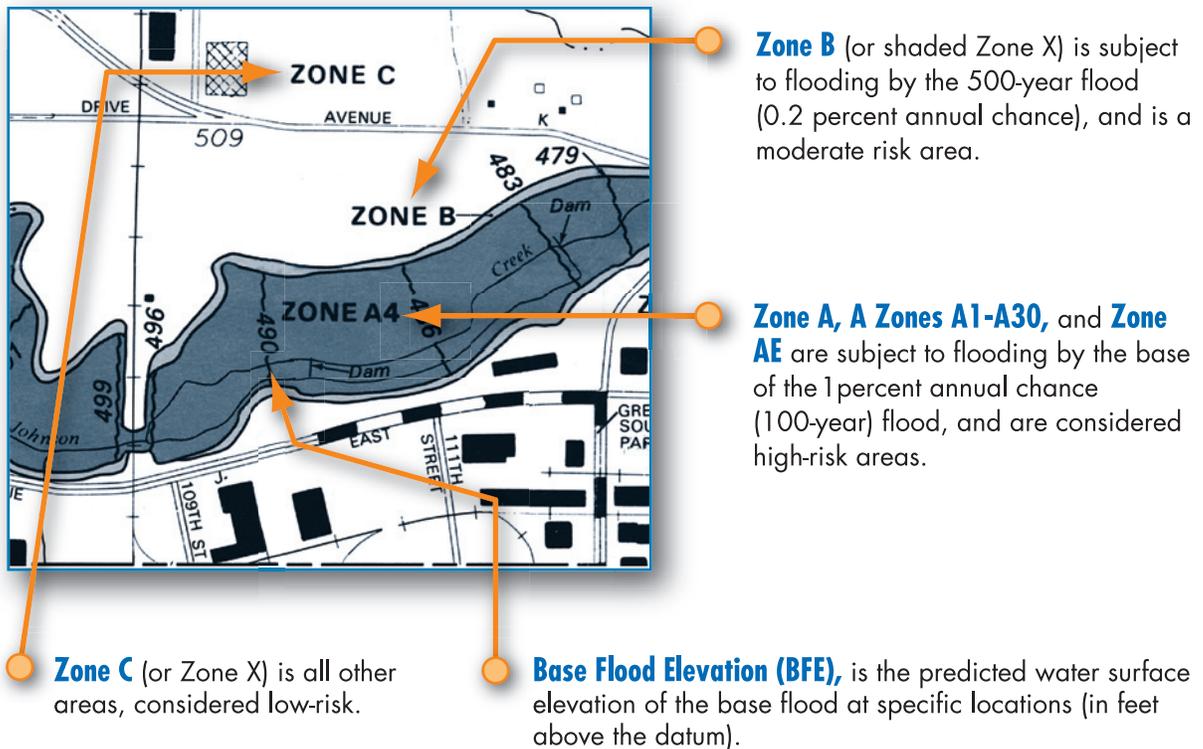
Figure 2-3: Riverine flood hazard zones

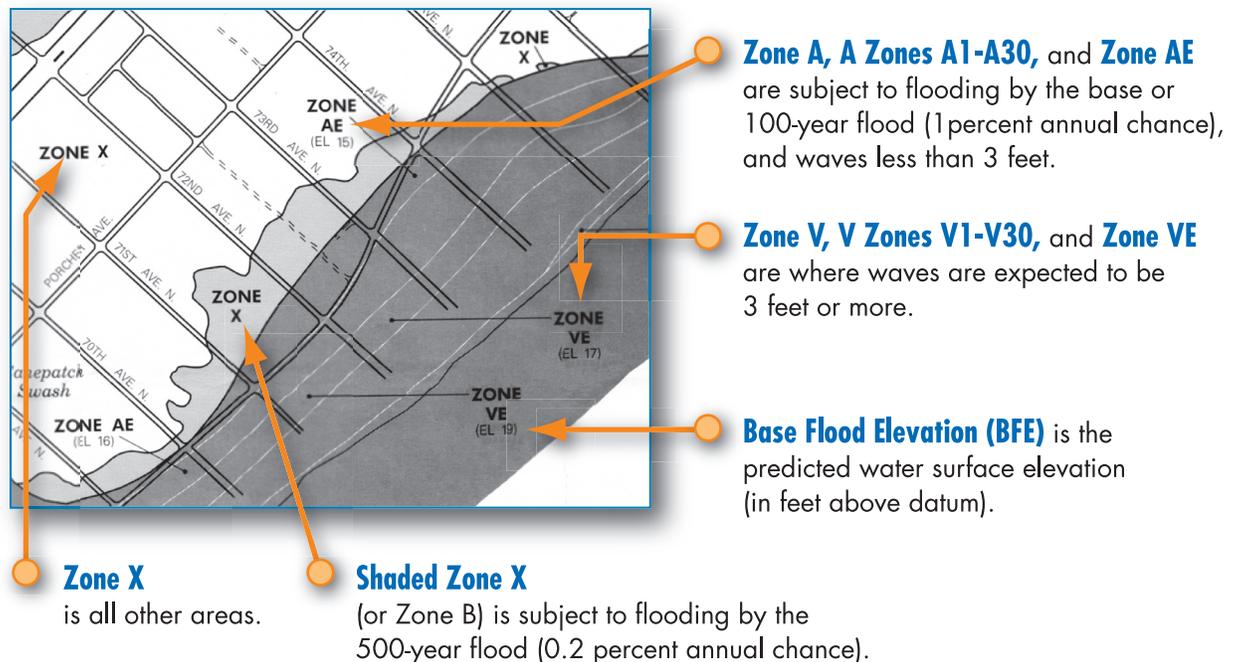
Figure 2-4: Coastal flood hazard areas

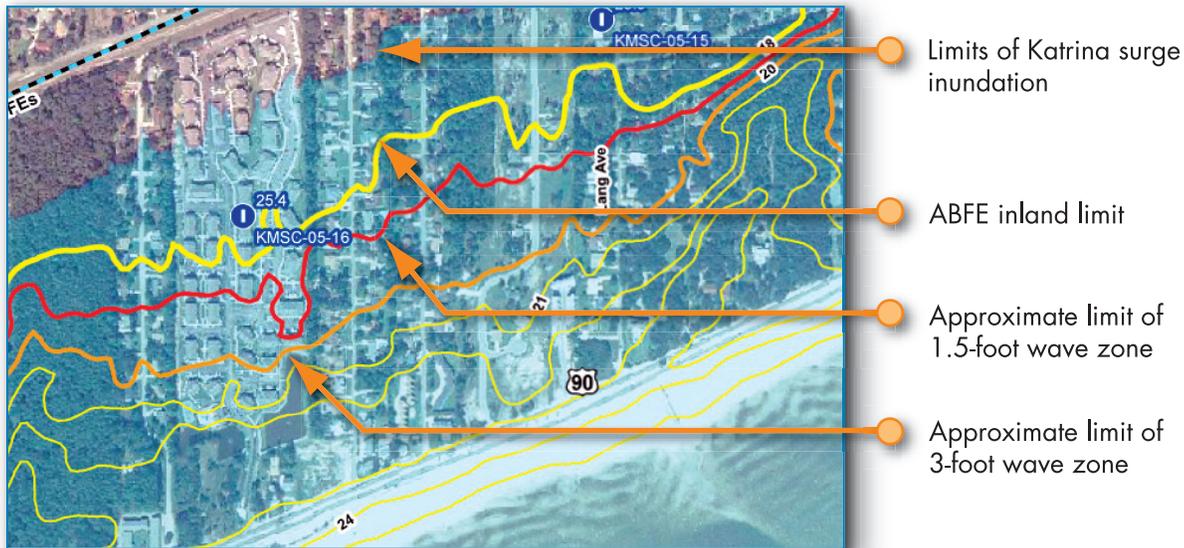
Figure 2-5: Example of a flood recovery map showing ABFEs and other flood hazard information.

FEMA works closely with communities to develop new flood hazard data or revise existing data during the standard flood study process. Updating flood hazard data includes the analysis of historical data. If a major flood event significantly alters the physical environment or if it is determined to be statistically significant, FEMA may decide to release Advisory BFEs (ABFEs) and Flood Recovery Maps (see Figure 2-5).

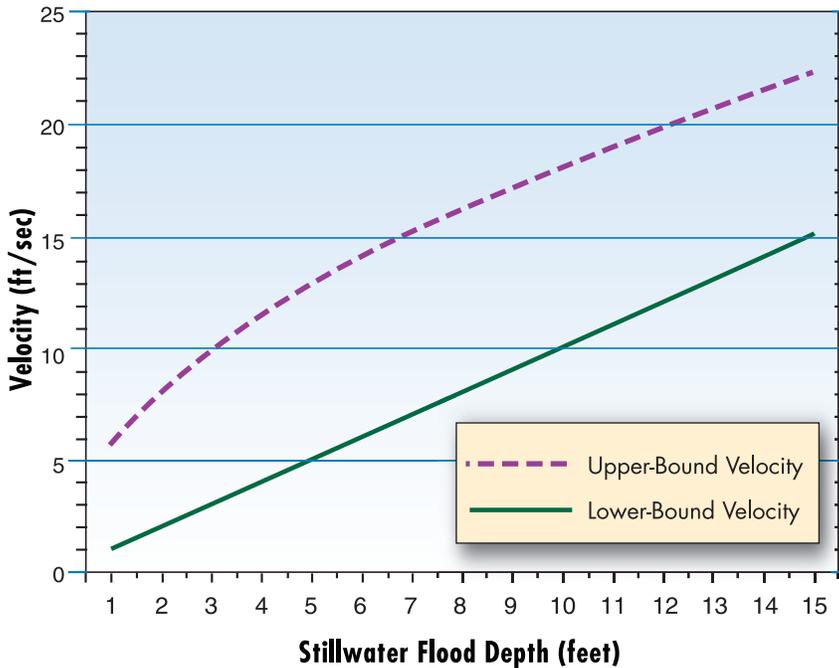
Figure 2-7:
Velocity as a function of
stillwater flood depth

Figure 2-7 shows the general relationship between velocity and stillwater depth. For design purposes, actual flood velocities are assumed to lie between the upper and lower bounds. Conservative designs will take into account the upper bound velocities.

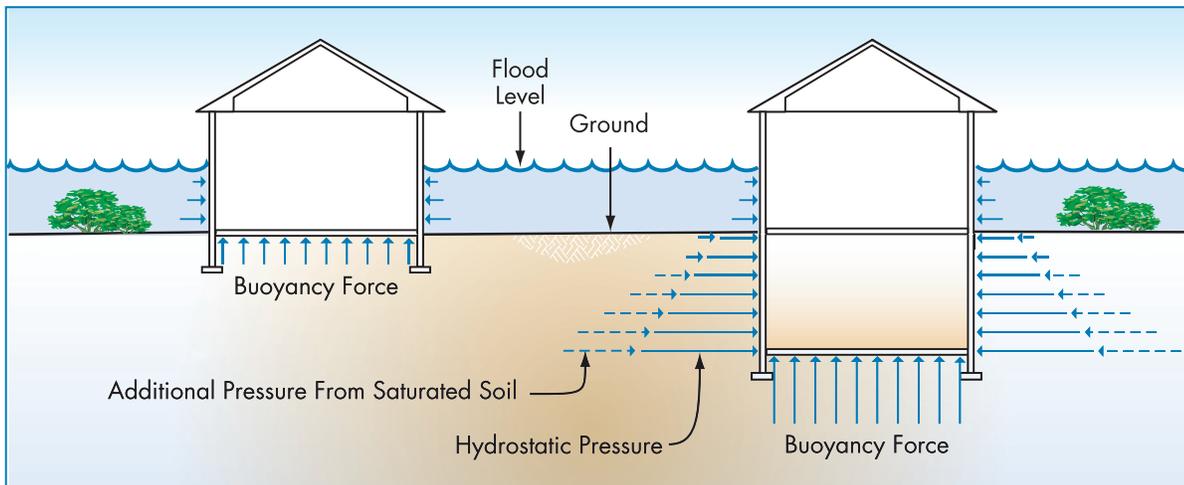
Figure 2-8: Hydrostatic loads on buildings

Buoyant forces resulting from the displacement of water are also of concern, especially for dry floodproofed buildings and aboveground and underground tanks. Buoyancy force is resisted by the dead load of the building or the weight of the tank. When determining buoyancy force, the weight of occupants or other live loads (such as the contents of a tank) should not be considered. If the building or tank does not weigh enough “empty,” then additional stabilizing measures need to be taken to avoid flotation. This becomes a significant consideration for designs intended to dry floodproof a building. Buoyancy force is slightly larger in saltwater, because saltwater weighs slightly more than fresh water.

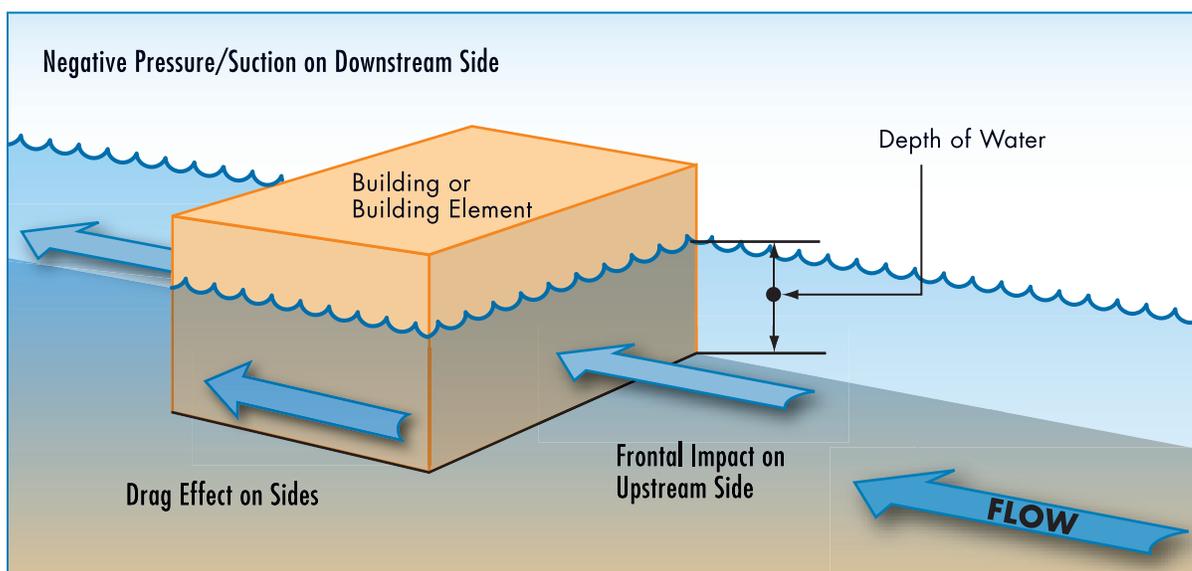
Figure 2-9: Hydrodynamic loads on a building or building element

Water flowing around a building or a structural element that extends below the flood level imposes hydrodynamic loads. The loads, which are a function of flow velocity and structure geometry, include frontal impact on the upstream face, drag along the sides, and suction on the downstream side (see Figure 2-9). Ways to determine or estimate flood velocities are described in Section 2.1.2.2 and Section 2.1.2.3.

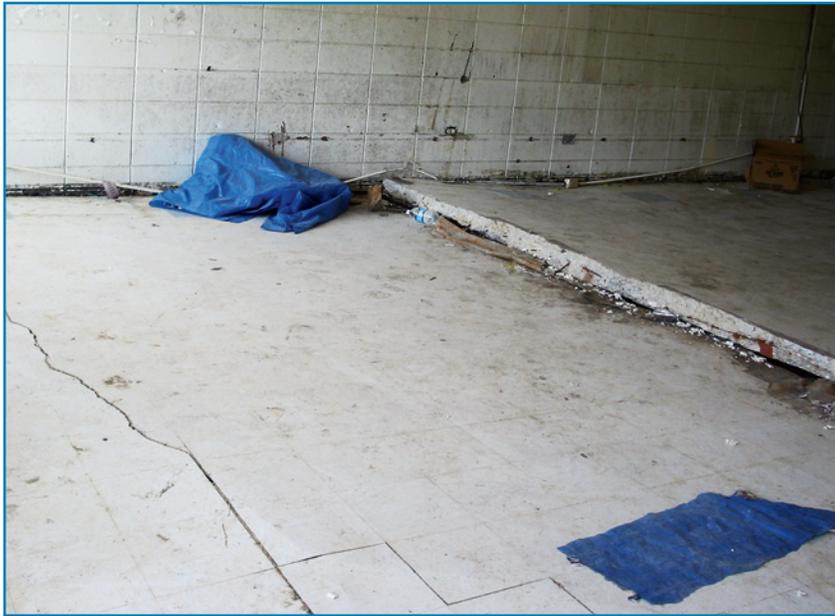
Figure 2-15:
Concrete floor ruptured
by hydrostatic pressure
(buoyancy). Hurricane
Katrina (2005)

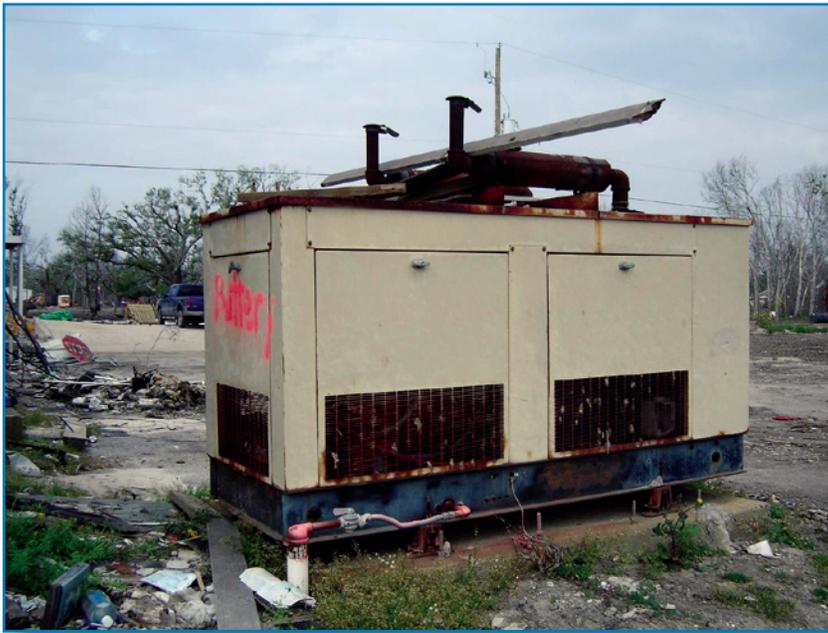
Figure 2-20: Although it was anchored and not displaced by floodwaters, this generator was out of service after being submerged.

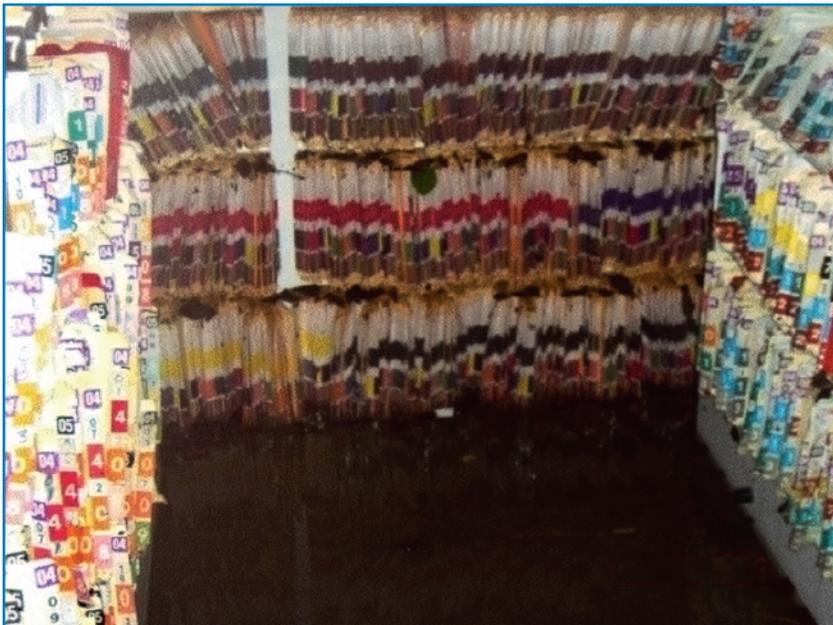
Figure 2-21:
Medical records saturated
by floodwaters

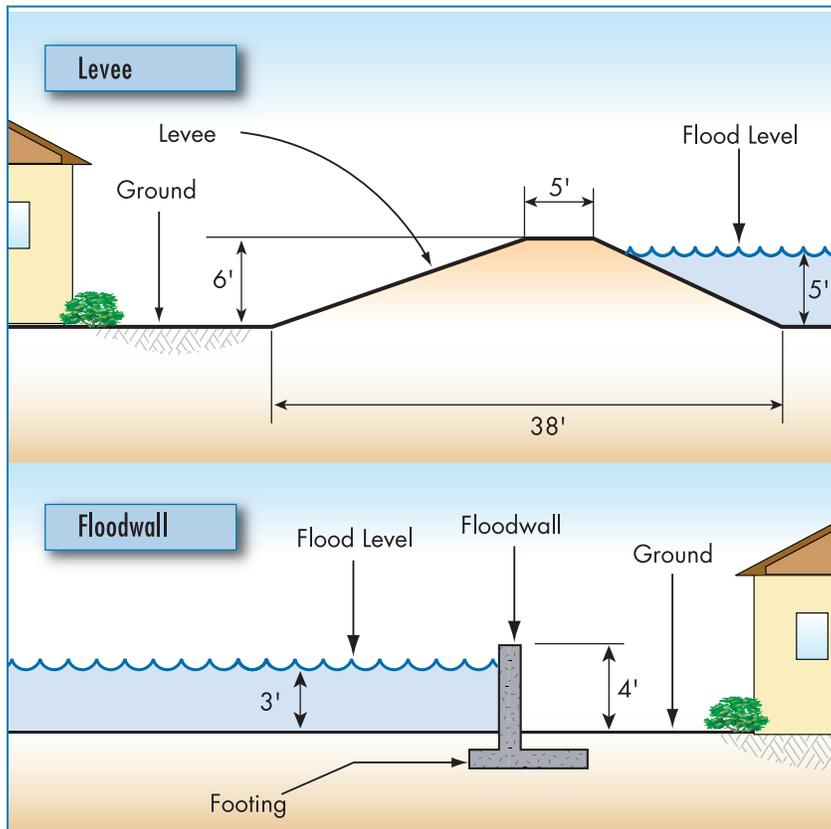
Figure 2-23:
Schematic of typical
earthen levee and
permanent floodwall

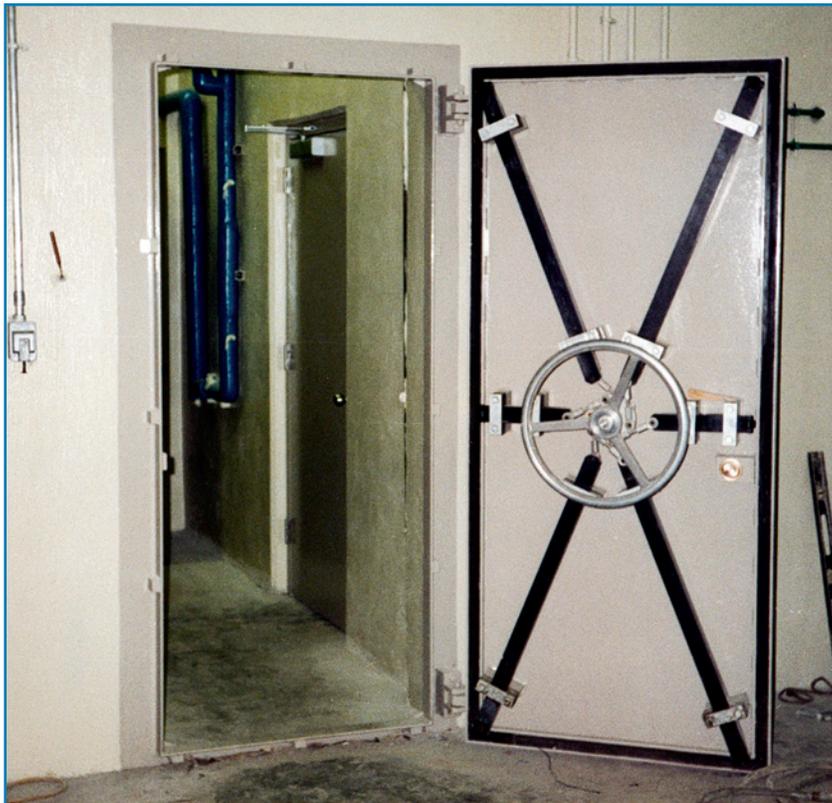
Figure 2-29:
Permanent watertight
doors for deep water
SOURCE: PRESRAY CORPORATION

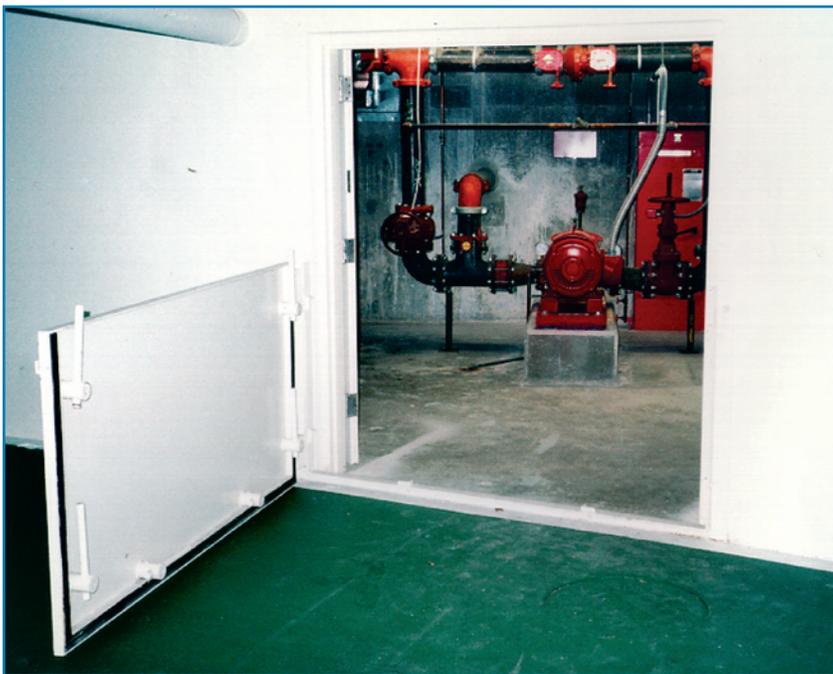
Figure 2-31:
Equipment room with
watertight door

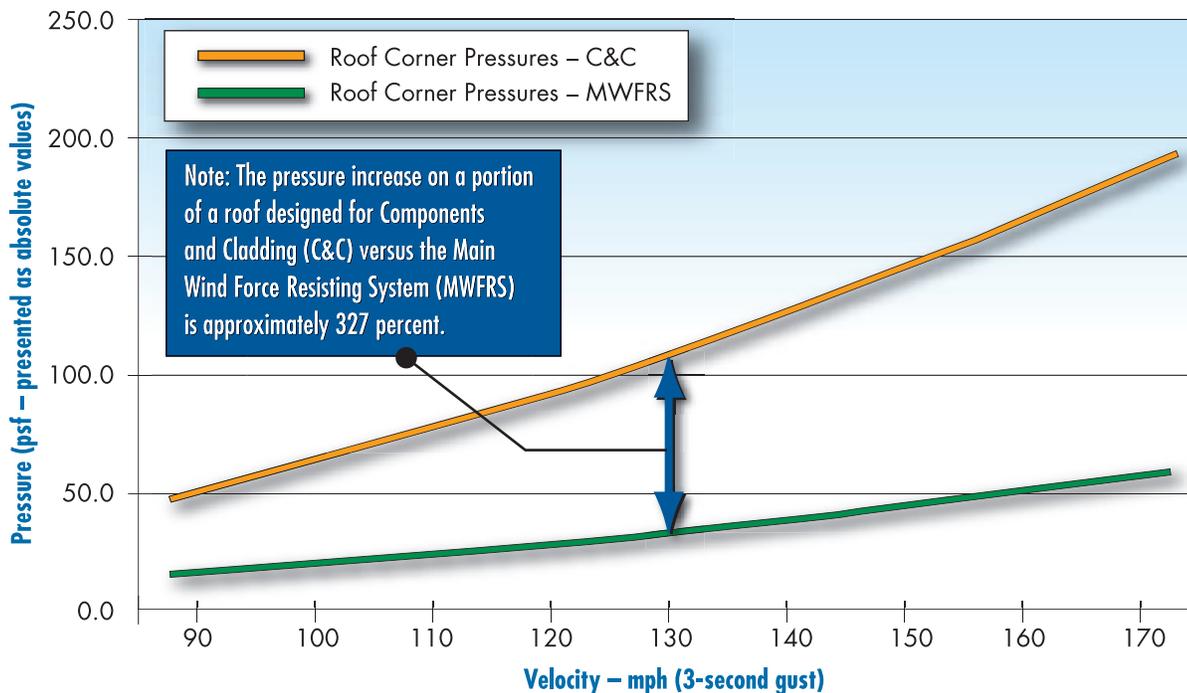
Figure 3-5: Wind pressure as a function of wind speed

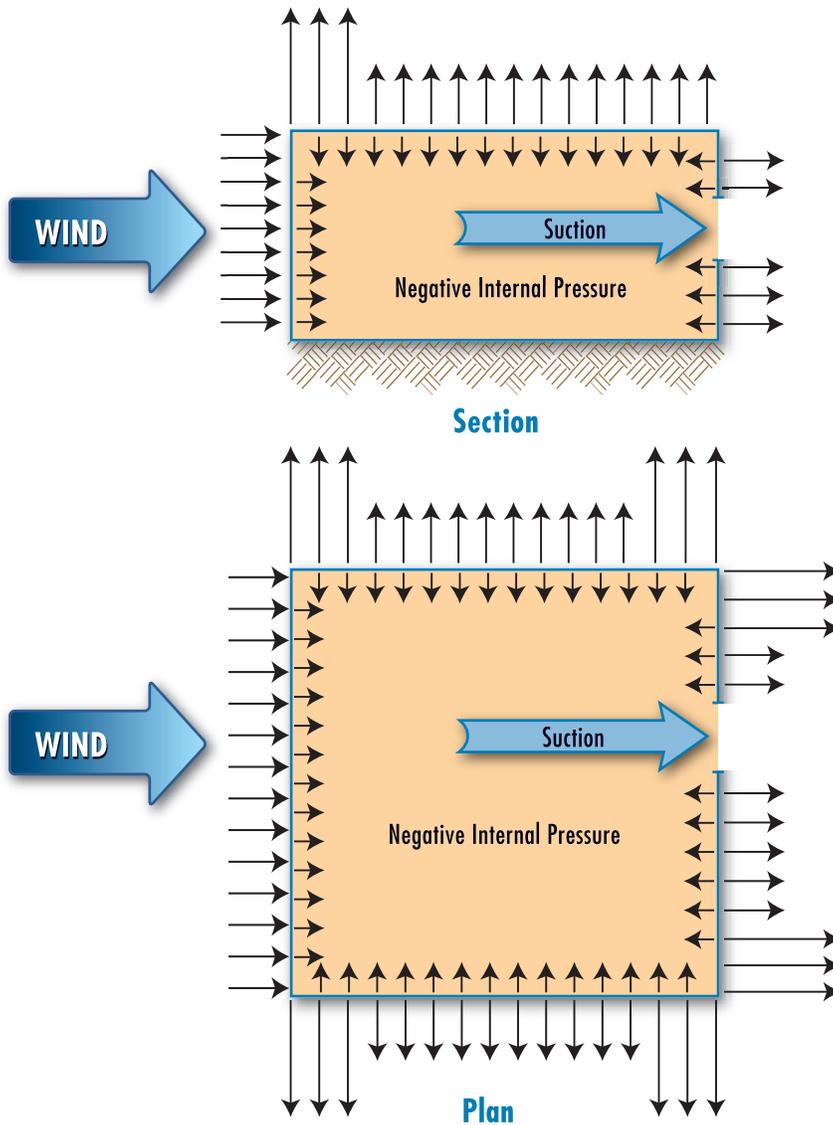
Figure 3-7:
Schematic of internal
pressure condition when the
dominant opening is in the
leeward wall

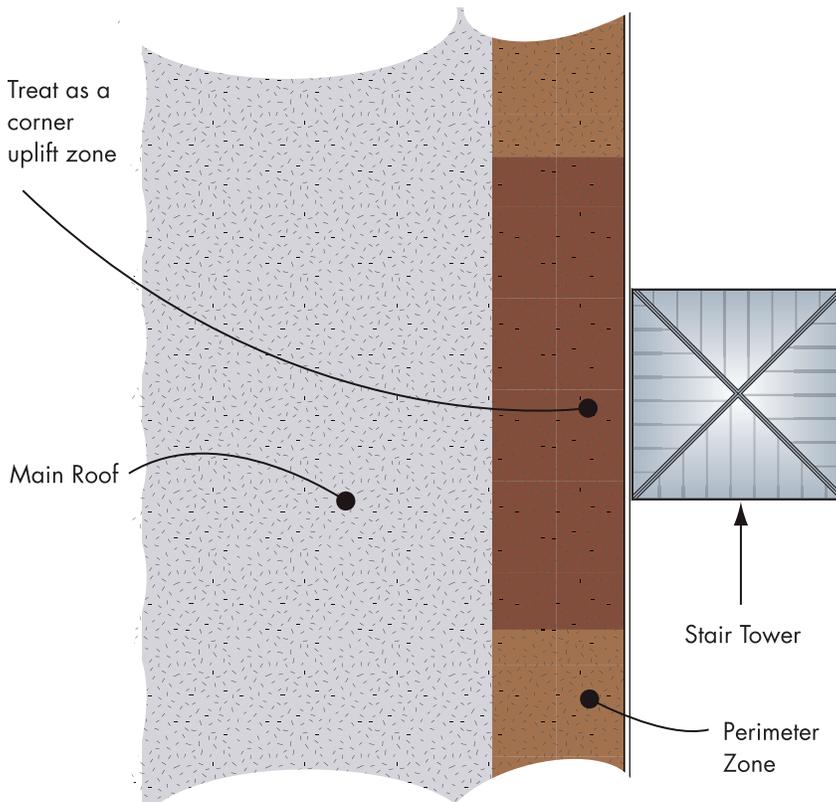
Figure 3-11:
Plan view of a portion of the building in Figure 3-10 showing the use of a corner uplift zone in lieu of a perimeter uplift zone on the low-slope roof in the vicinity of the stair tower

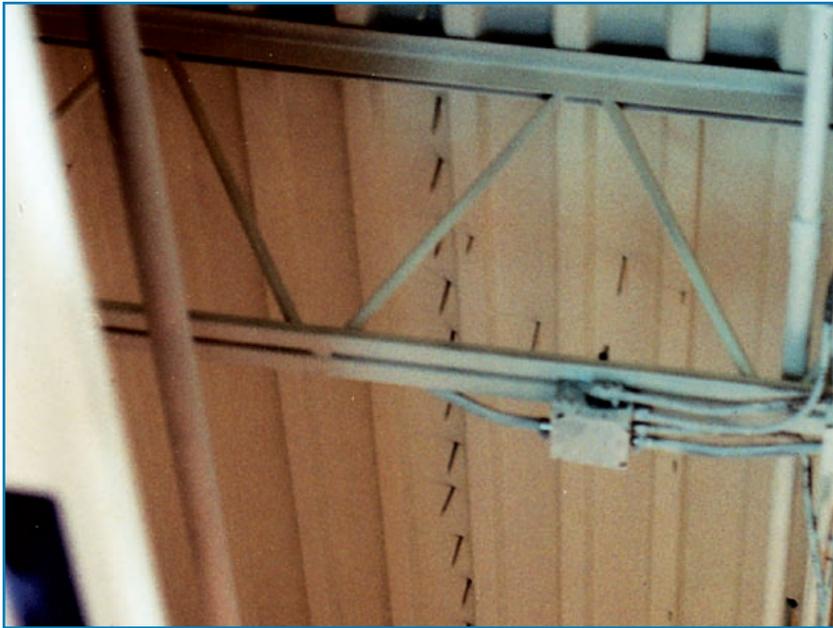
Figure 3-60:
View of the underside of a steel deck showing the mechanically attached single-ply membrane fastener rows running parallel to, instead of across, the top flange of the deck.

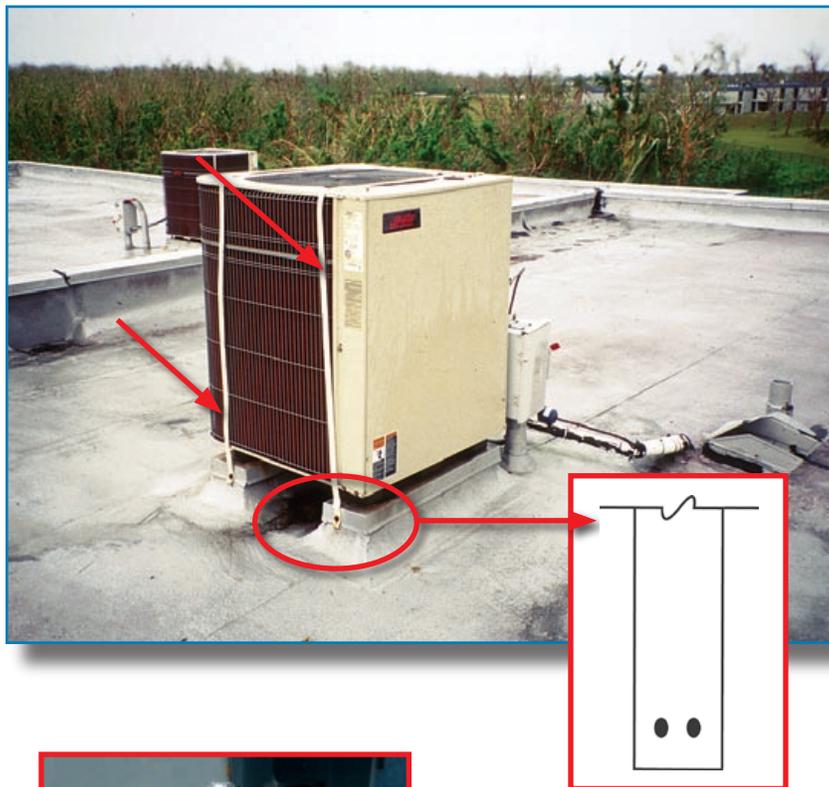
Figure 3-75:
Failure of vibration isolators that provided lateral resistance but no uplift resistance caused equipment damage. A damaged vibration isolator is shown in the inset. Hurricane Katrina (Mississippi, 2005)

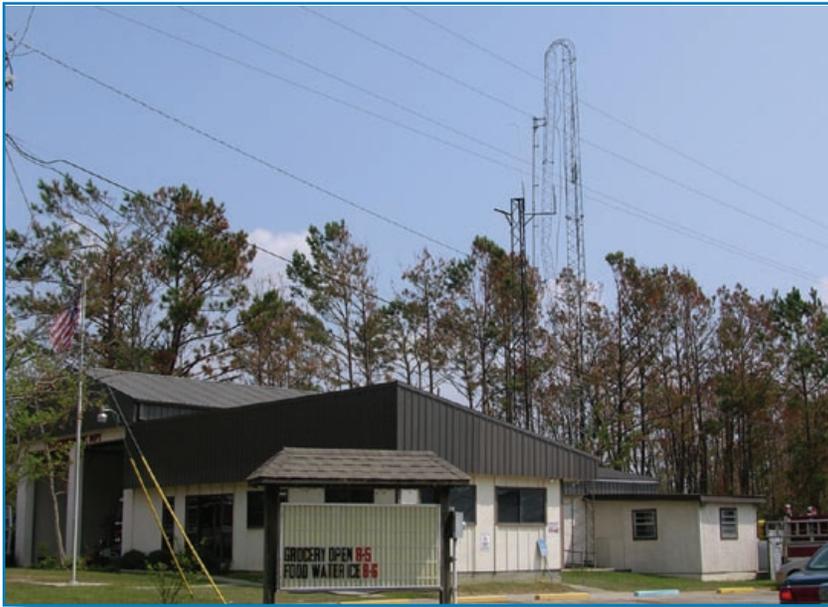
Figure 3-80:
The antenna tower at
this fire station buckled.
Hurricane Katrina
(Mississippi, 2005)

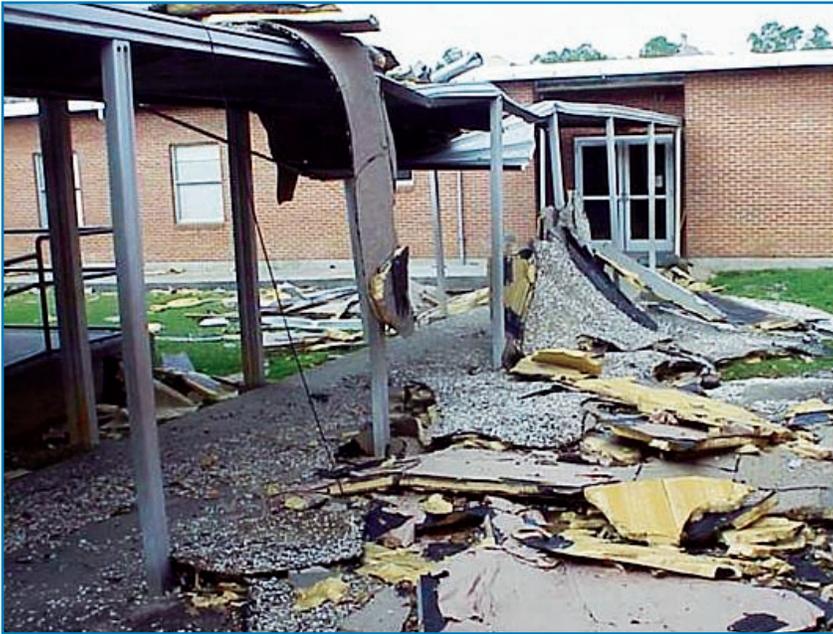
Figure 3-83:
Open walkways do not provide protection from wind-borne debris.
Hurricane Katrina
(Mississippi, 2005)

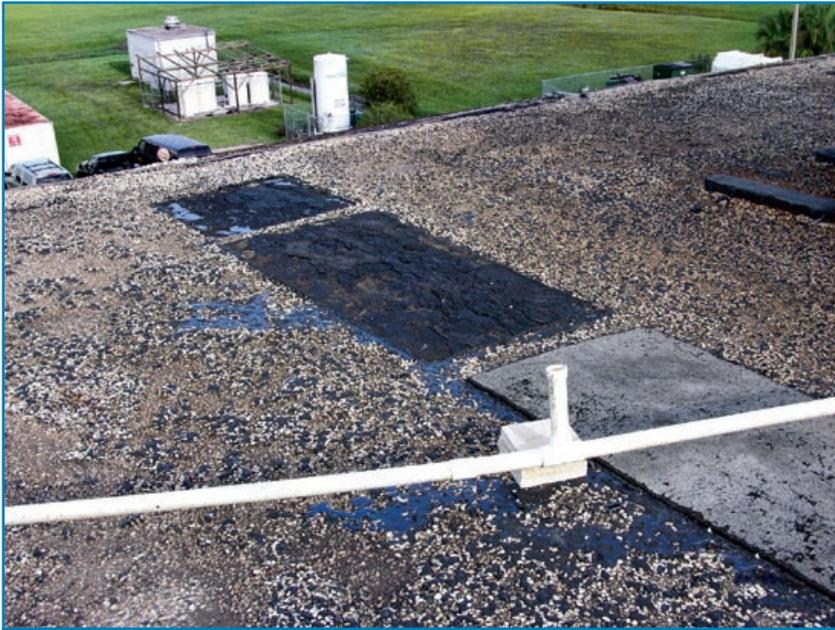
Figure 3-92:
To avoid walkway pad
blow off, as occurred
on this hospital roof,
walkway pads are not
recommended. Hurricane
Charley (Florida, 2004)

Walkway pads: Roof walkway pads are frequently blown off during hurricanes (Figure 3-92). Pad blow-off does not usually damage the roof membrane. However, wind-borne pad debris can damage other building components and injure people. Walkway pads are therefore not recommended in hurricane-prone regions.

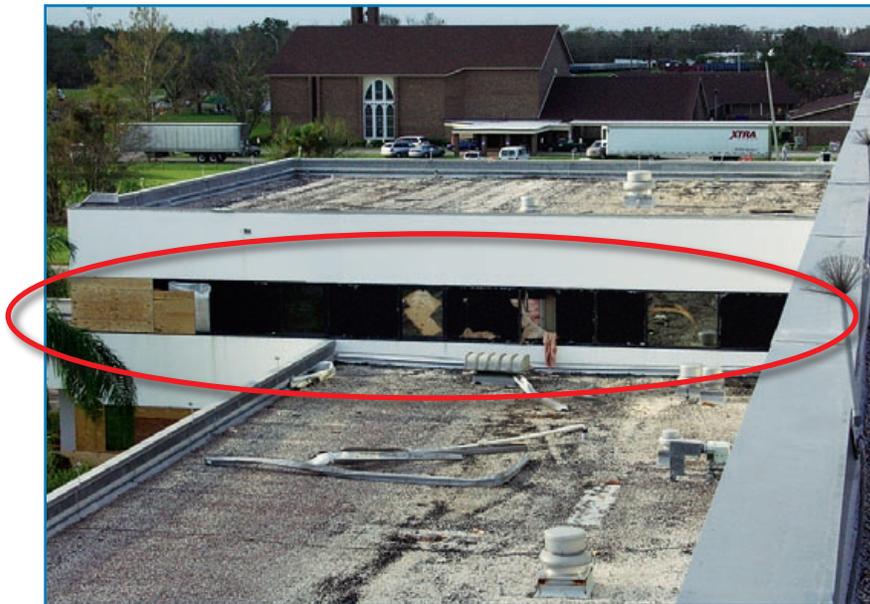
Figure 3-114:
Aggregate from the hospital's built-up roofs broke several windows in the intensive care unit, which had to be evacuated during the hurricane. Hurricane Charley (Florida, 2004)

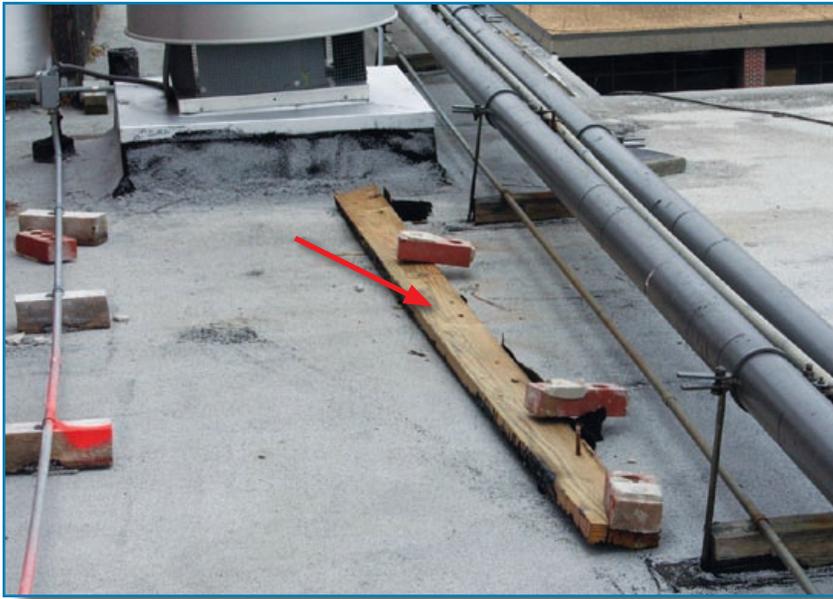
Figure 3-116:
The edge nailer on top
of an old brick wall at a
hospital blew off because
it was inadequately
attached.
Hurricane Ivan (Florida,
2004)

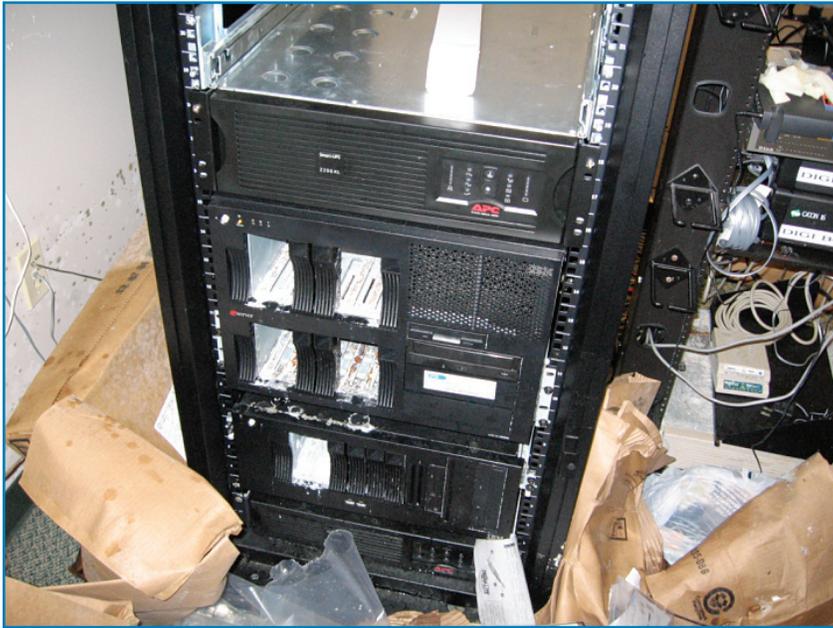
Figure 4-14:
Damaged computer
network equipment at
Hancock Medical Center

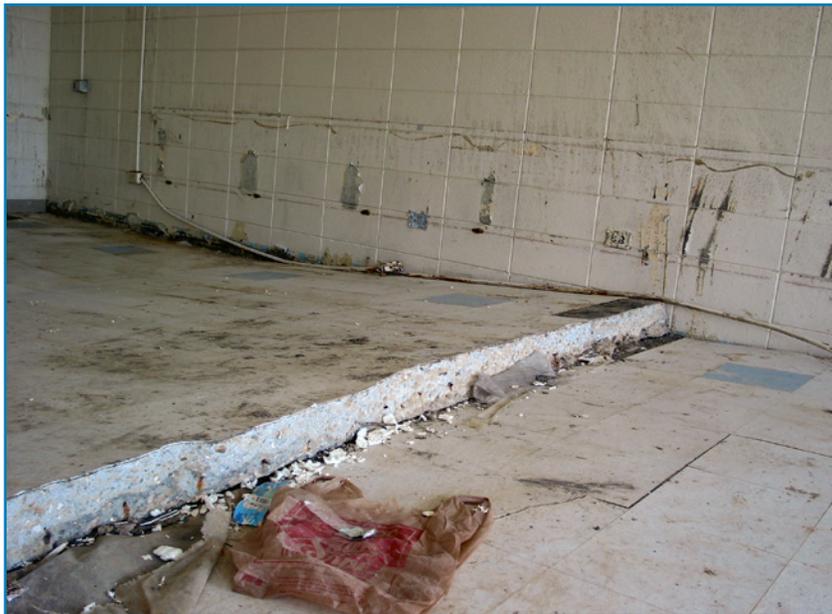
Figure 4-23:
Cracked concrete floor
slab at Charles B. Murphy
Elementary School

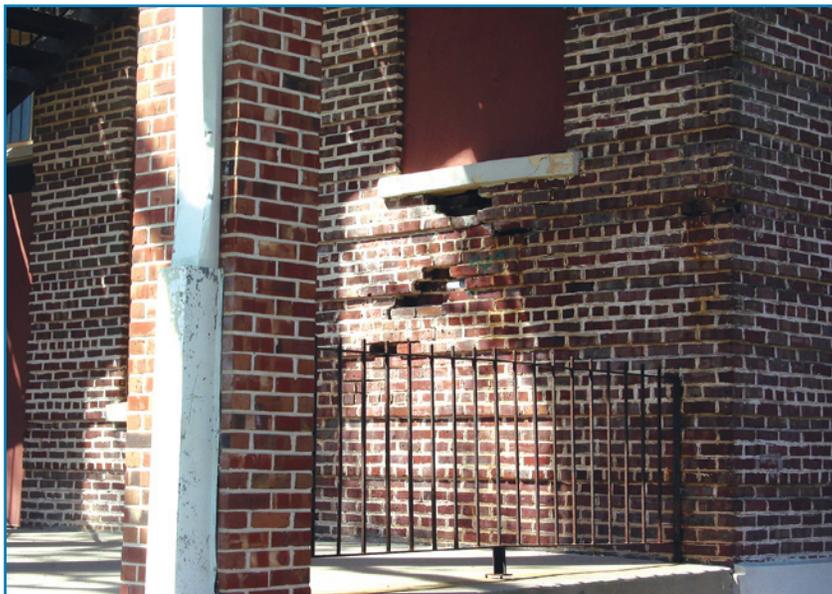
Figure 4-26:
Cracked brick veneer at
St. Stanislaus High School

The exterior brick veneer walls at the Pass Christian Middle School and at St. Stanislaus cracked and separated from the wall framing under the impact of storm surge (see Figure 4-26). This kind of damage usually results from a failure of brick ties that did not manage to hold the brick in place. In many cases these attachments can corrode and allow the brick veneer to move under lateral pressure. Such damage allows the penetration of water into the interior, where additional damage to building contents is inevitable.

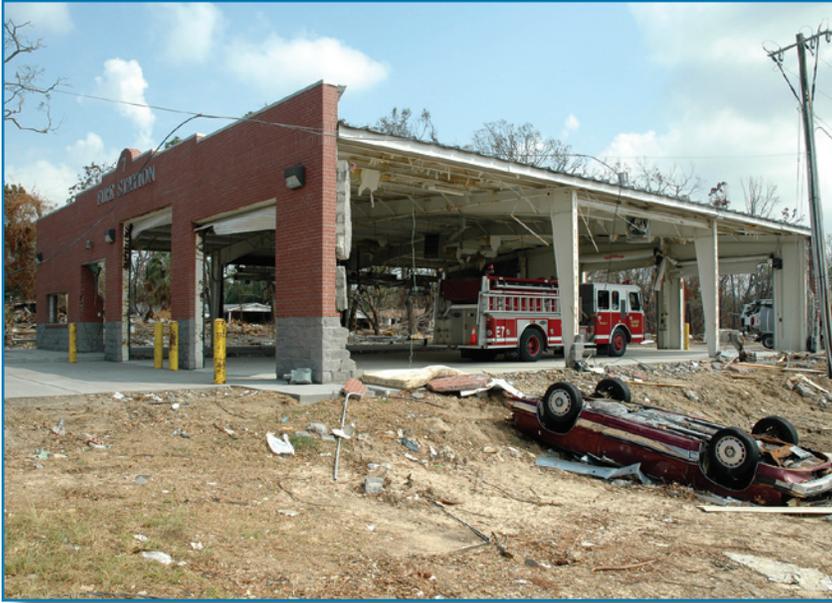
Figure 4-40:
Exterior walls on the
Gulfport Fire Station #7
washed away by the
storm surge

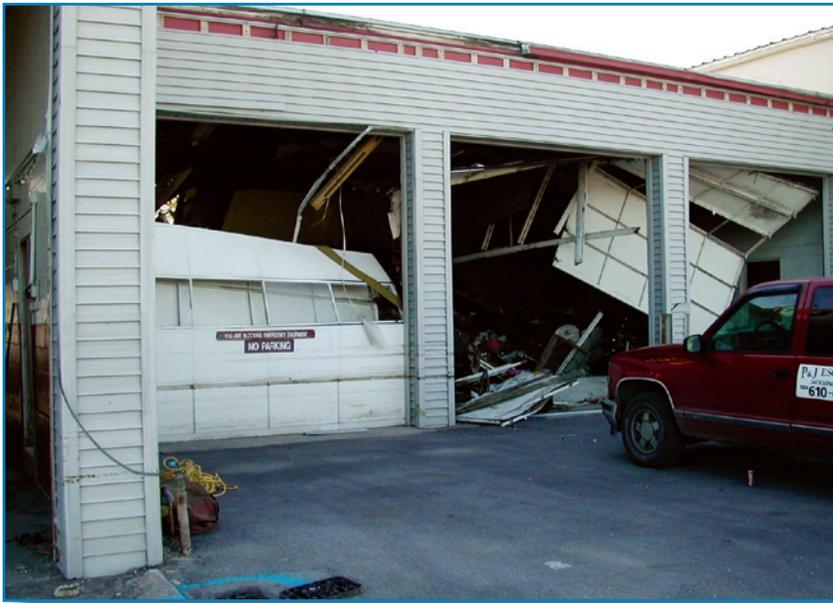
Figure 4-45:
Damaged apparatus bay
doors at Port Sulphur
Volunteer Fire Department.

Fire stations are especially susceptible to breaches of the building envelope, because of their large sectional and rolling doors that are usually not strong enough to resist wind forces, and even less so the hydrodynamic forces of storm surge. The apparatus bay doors failed in many fire stations affected by flooding. (see Figures 4-39 and 4-45).
