CASE STUDY

Restoring Native Ecosystems to Build Resilience

SANTA CLARA PUEBLO

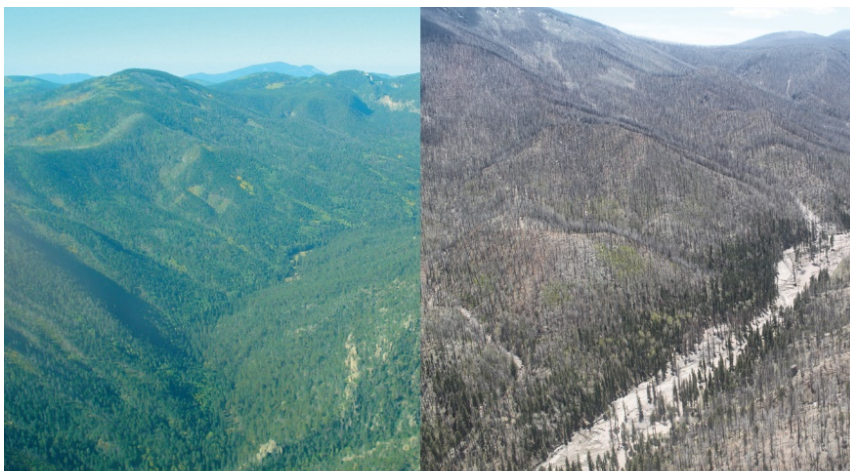
Figure 1. Before and after photographs of the Santa Clara Canyon. Source: New Mexico PBS.

frequently flooded, creating large-scale debris flows caused by the floods' erosion of the canyon walls. After the 2013 monsoons, roads leading through the canyon lay broken apart and bridges washed away. All four water control structures of the creek's tributaries were breached and critical infrastructure along the river, including a fire station and recreational facilities, were destroyed by the floodwaters. Riparian habitat and 100% of the fish population was eliminated by the debris flow. This was devastating to the Tribe, who view protecting their water source as protecting their way of life, expressed by the emblem "water is life".

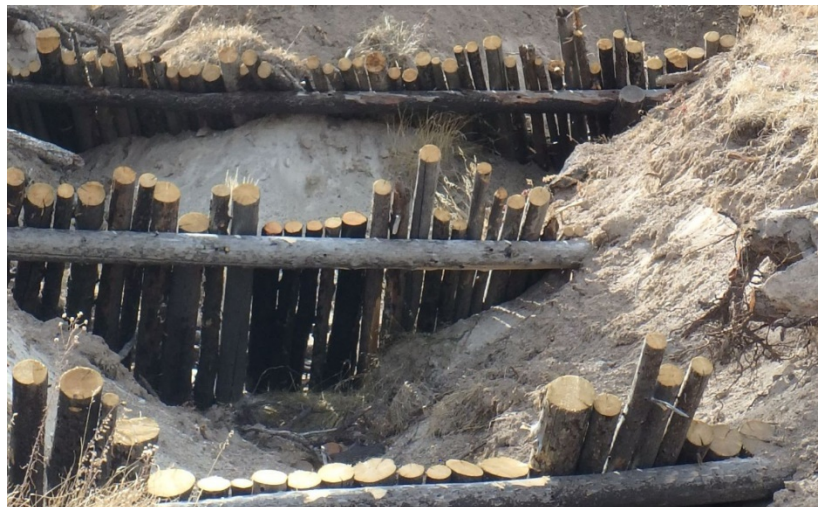
Figure 2. An example of a bank stabilization technique employed in Santa Clara Pueblo that uses natural materials. Source: Santa Clara Pueblo Forestry.

Stream restoration projects applied principles of bioengineering, engineering with nature, and natural channel design, including the use of natural materials and vegetation for construction and the installation of bottomless culverts to provide unobstructed routes for water, sediment, and fish. Bank stabilization and channel reconstruction efforts were essential to restore habitat, control erosion, and connect floodplains. In an effort to restore and strengthen the forested tribal land, local leadership set an annual goal of planting 200,000 locally sourced seedlings.

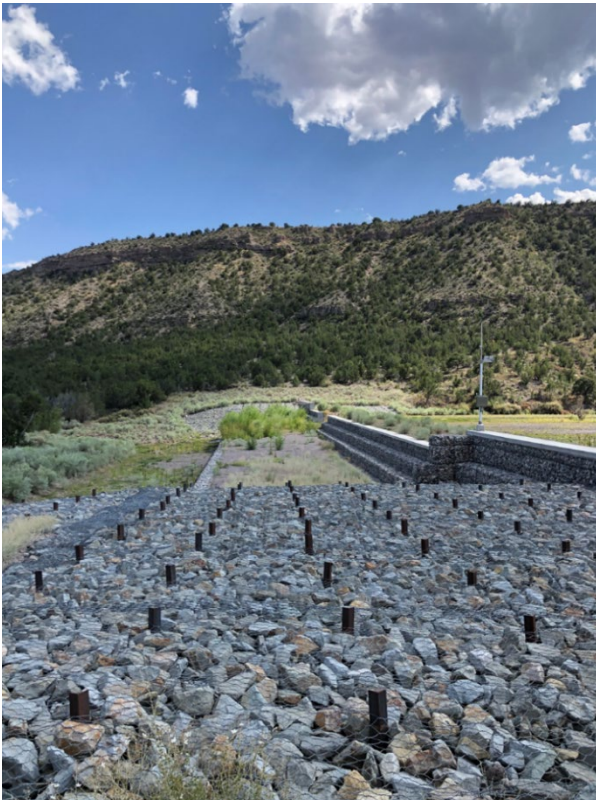
Figure 3. A mitigation project installed in the canyon to treat water runoff before it reaches the main stem of the creek improves the resiliency of the watershed while the natural vegetation recovers.
