Observations on the Behavior of Storm Surge, Waves and Flooding on the Mississippi Coast, Hurricane Katrina, 2005: A Protocol Study

Developed by FEMA, Mitigation Division
Hazards & Performance Analysis Group

FEMA-DR-1604-MS - Jackson - AFO

May 2006

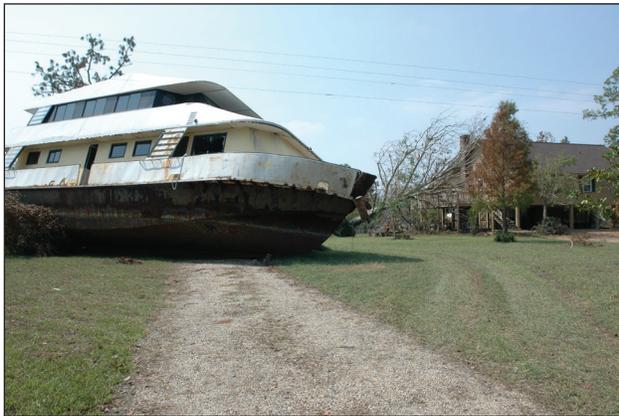
A boat that was displaced by the surge

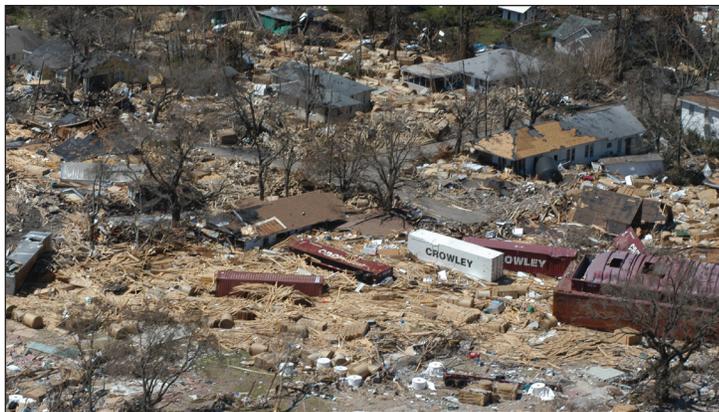
Large rolls of industrial paper and other debris strewn about with shipping containers and a barge

A barge broke loose from the port at Gulfport loaded with huge spindles of brown paper product. It was forced inland on the surge and landed on top of an apartment building, killing the people who were harbored inside (#9).

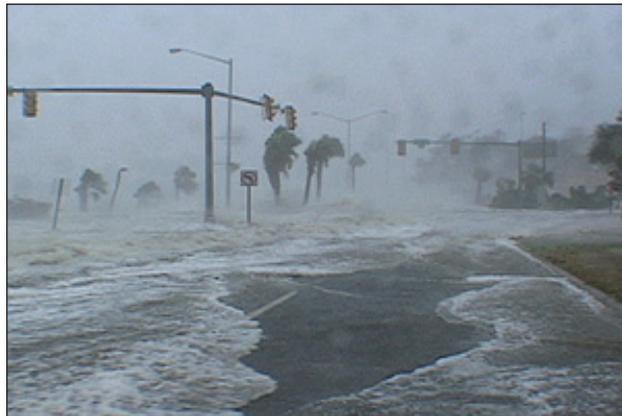
The advance and retreat of breaking waves crossing Highway 90 as Katrina’s surge began to arrive
Photo by Mike Theiss, The Ultimate Chase

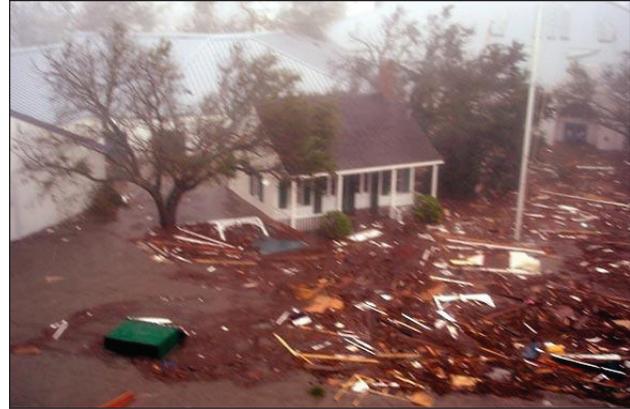
Debris carried by the surge at Biloxi City Hall
The SunHerald

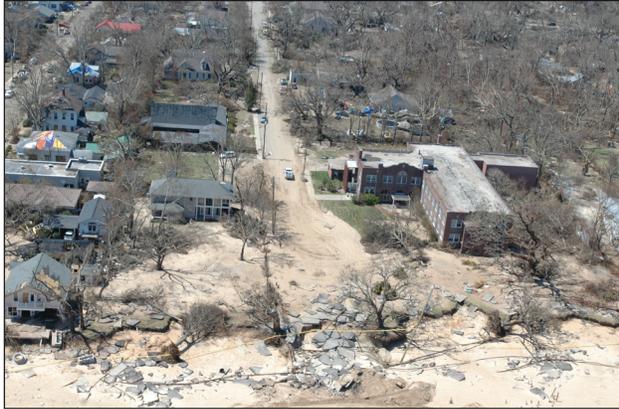
Sediment deposition at the shoreline

Katrina's surge carried with it a great load of sand and sediment. When the water velocity slowed to less than 3 ft/sec most sediment types were deposited. Thick depositions in houses and upon roads were common (photos 4:1,3,4) along the Gulf coast. Even if a building structurally survived the forces of the surge and wave action, it still might have been destroyed by the sand-sediment deposited by floodwaters inside the house (4:3).

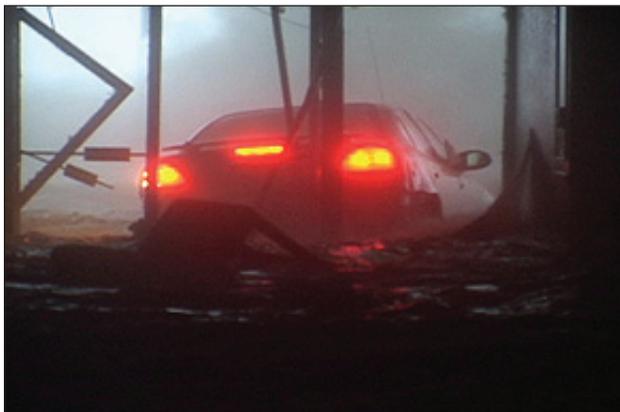
Buoyant car crashing into hotel lobby

Car buoyancy and transport was reported by many people. Though vehicles vary in buoyancy as a function of their volumes, the surge and wave forces were so great that the relatively small differences in vehicle volume was not the limiting factor if a vehicle was transported in Katrina.

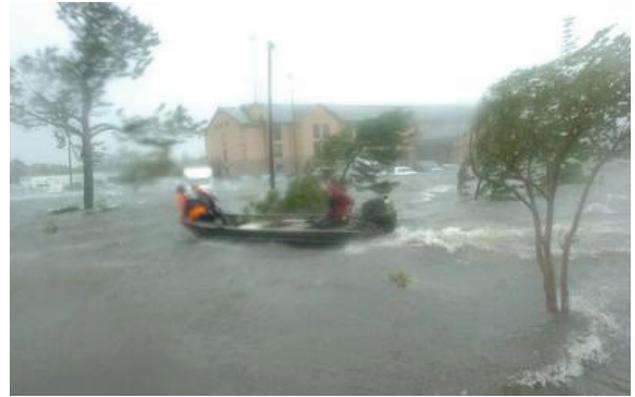
Photo 1-14

Fire and rescue personnel in surge and waves near Interstate-10, Pascagoula, MS.

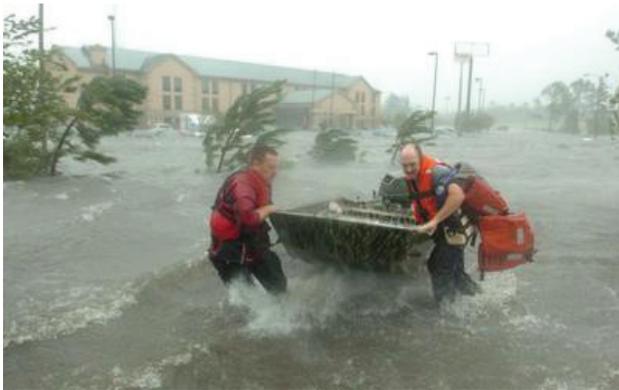
Photo 1-15

Fire and rescue personnel in surge and waves near Interstate-10, Pascagoula, MS.

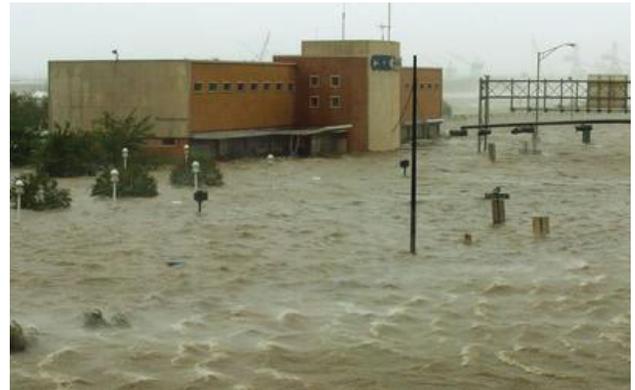
Photo 1-16

Surge with wind-crested waves, Water Street, Mobile, AL.

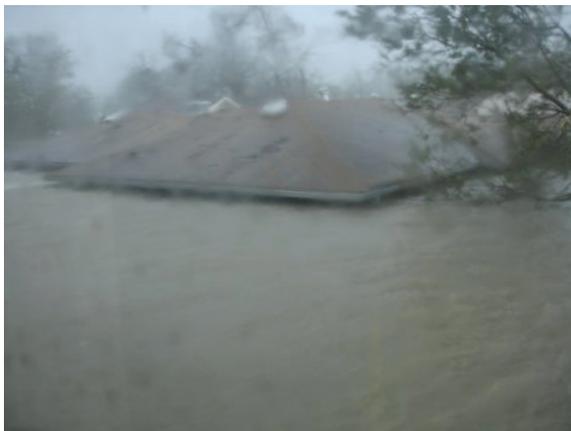
Photo 1-17

Peak surge flooding on Reynoir Street, Biloxi, MS.

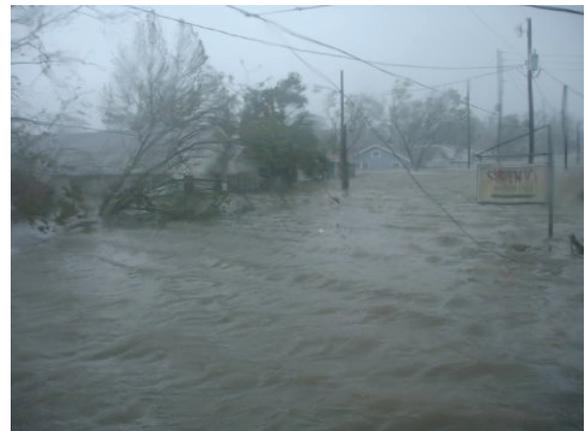
Photo 1-18

Peak surge flooding on Reynoir Street, Biloxi, MS.

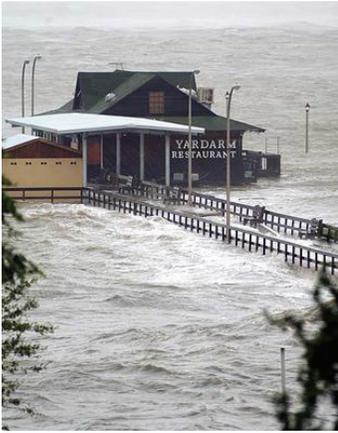
Photo 1-19

Surge and wave action at Fairhope Pier and Yardarm Restaurant, Mobile Bay, AL.

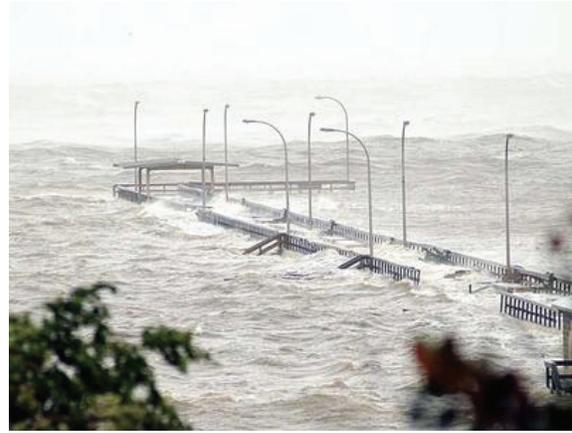
Photo 1-20

Surge and wave action at Fairhope Pier and Yardarm Restaurant, Mobile Bay, AL.

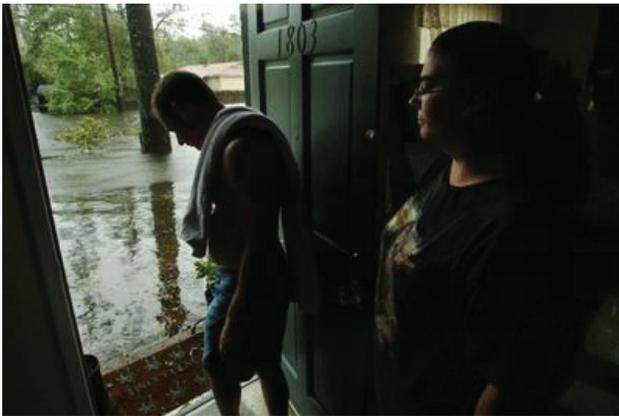
Photo 1-21

A couple watches floodwaters rise outside their home, Mobile, AL.

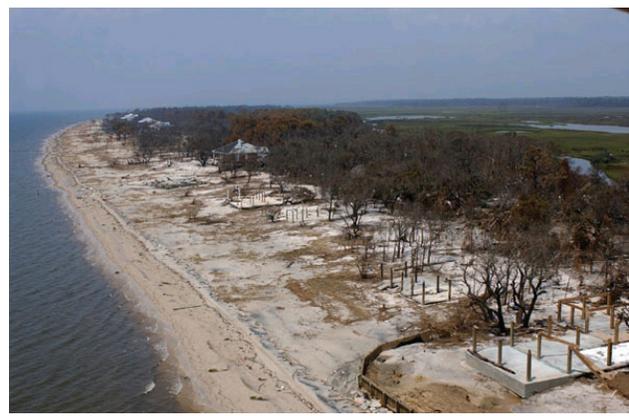
Photo 1-22

Effects of surge and waves at Belle Fountain Beach, near Ocean Springs, MS.

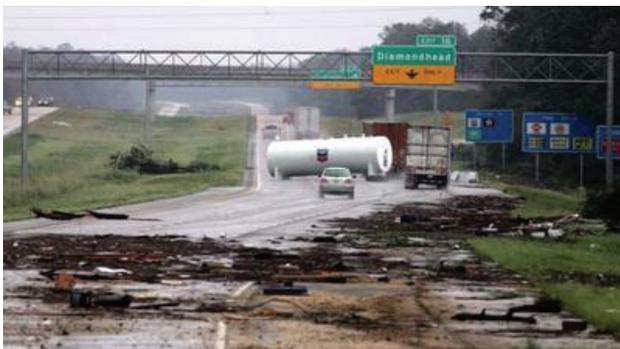
Photo 2-5

Similarly, an industrial-sized Chevron fuel tank was loosed during the hurricane and moved with the floodwaters, finally settling in the westbound lanes of Interstate #10 in Diamondhead (2:5). A barge at the port that became loose carried industrial rolls of brown paper product, approximately 3 ft in diameter and 6 feet tall. Although these rolls were extremely heavy, they traveled with the surge and were strewn several blocks inland (2:9)

Commercial fuel tank transported on the surge on to Interstate 10, Diamondhead, MS.

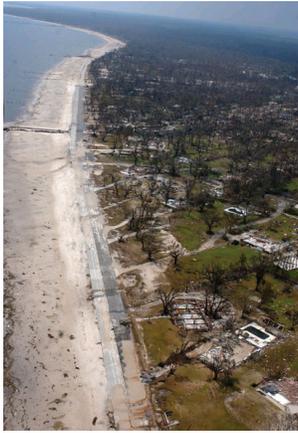
Photo 4-1

Sand washover deposited by the surge in Waveland, MS.
